E5 | Acid Sulfate Soils

## GLNG EIS Supplement

### Common Pipeline Infrastructure Corridor - ASS assessment of additional field data

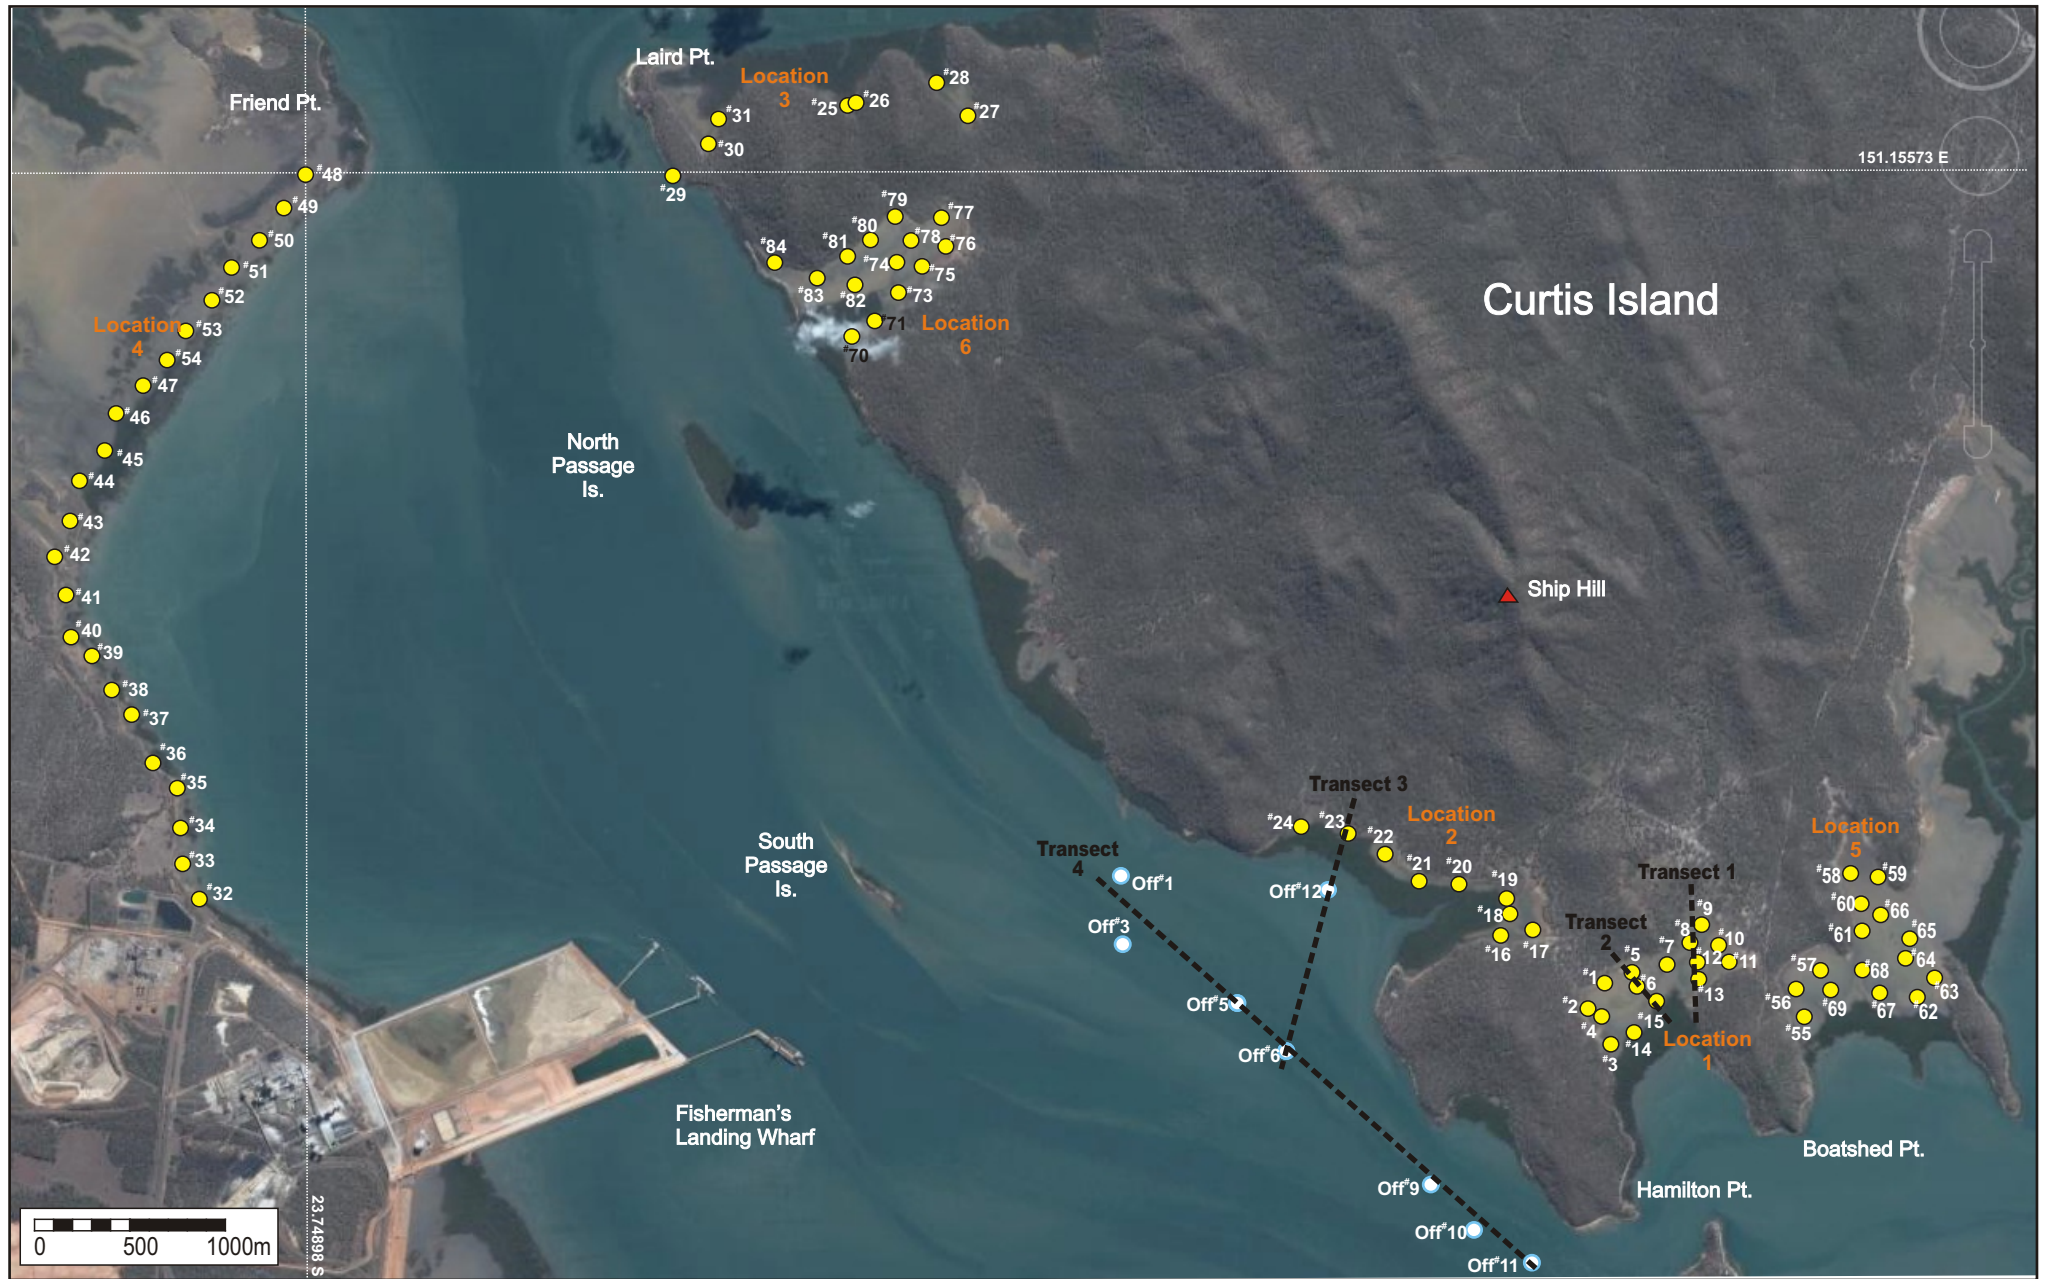
FIGURE 1-2 Acid sulfate core site and stratigraphic transect locations.

Attached Figure 1 (Appendix A) shows previous GeoCoastal locations investigated in relation to the GLNG GTP (September 2009); Figure 2 (Appendix A) shows a section of the CPIC (GSDA Section) Route along with part of the GLNG GTP (September 2009) and the GHD investigation locations. Appendix C details the Acid Sulfate Soil studies completed to date, including methods of study, information collected and management plans.

Of the 23 boreholes GeoCoastal located along the coast of Kangaroo Island south of Friend Point (the GLNG GTP (September 2009)), 11 are considered relevant to the ASS condition of the material along the CPIC (GSDA Section) Route. These are GeoCoastal locations 44 to 54 (shown in attached Figure 1 – Appendix A) with a maximum investigation depth of 3.0 mbgl.
