Ecological Gaps Analysis and Assessment:

An assessment report to accompany the Electrification of Wells located in Fairview.

Document Number: 0007-650-PLA-0011

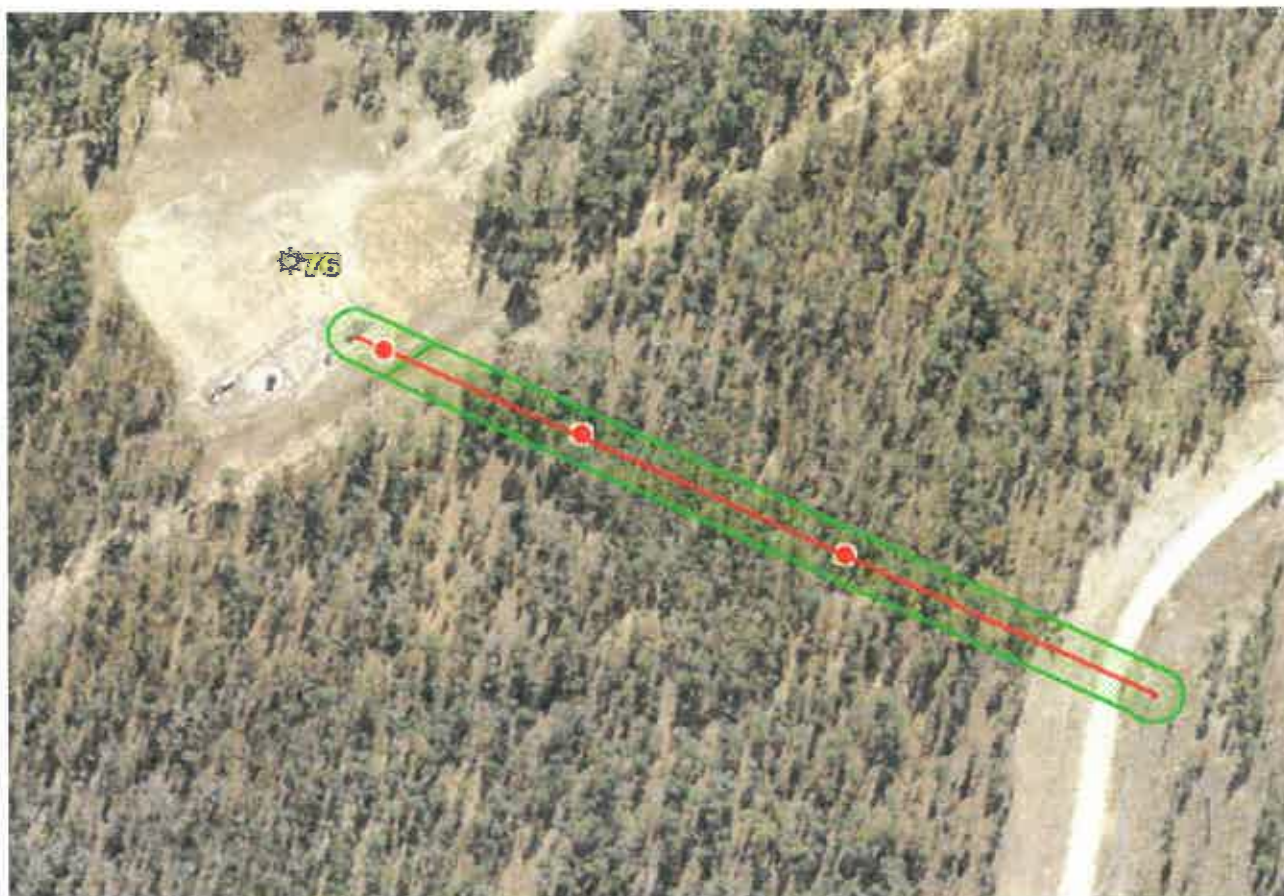
The majority of the land disturbance activities associated with the proposed electrification connections are wholly located within an area of existing disturbance. For these disturbances, there will be no impact to any Regional Ecosystem vegetation community or EPBC Act listed species habitat or TEC. There is only one well connection likely to contain ecological values. The connection of Fairview 76 will involve the clearing of Regional Ecosystem (RE) vegetation that is likely to be habitat for EVNT fauna species. The extent of the proposed disturbance is shown Figure 1.

Figure 1: Construction Disturbance Zone for the Fairview 76 Connection

Given the quality of the existing knowledge, the minimal impacts expected (<0.2 ha of remnant vegetation and fauna habitats will be cleared) and the proximity of previous survey efforts (all four of the reports above involved field ecological assessment approximately 2km of the impacted areas) it was concluded that no additional field assessment was required.

Given the presence of habitat and potential habitat features in the remnant vegetation a fauna spotter catcher will be used to clear the disturbance areas associated with the Construction Disturbance Zone for the Fairview 76 Connection.
