Ecological Assessment Report

47 Jump-up road upgrade

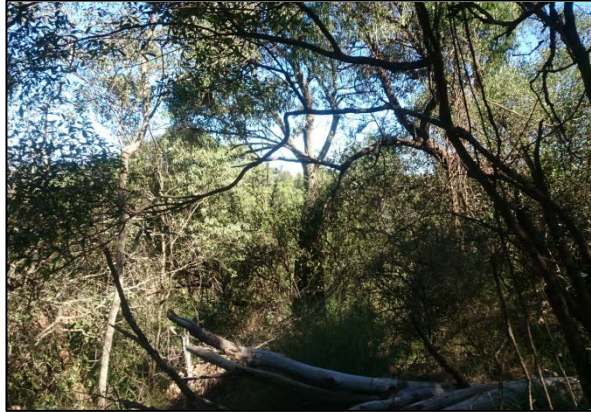
Plate 1 – VC1 Top of the scarp

Vegetation Community 1 (VC 1) – Semi-evergreen vine thicket (SEVT) on medium to coarse-grained sediments at the top of the scarp transitioning to fine-grained sedimentary rocks at the bottom of the scarp. This vegetation is typical of south facing sandstone escarpments in Fairview.

Plates 1 and 2 illustrate the typical structure and condition of this community.

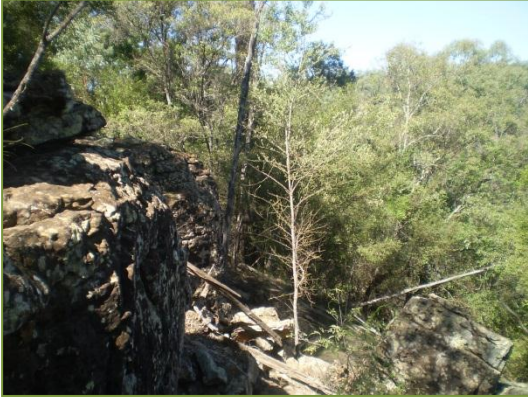
Landform: Top of scarp just below edge

Site 34 facing south

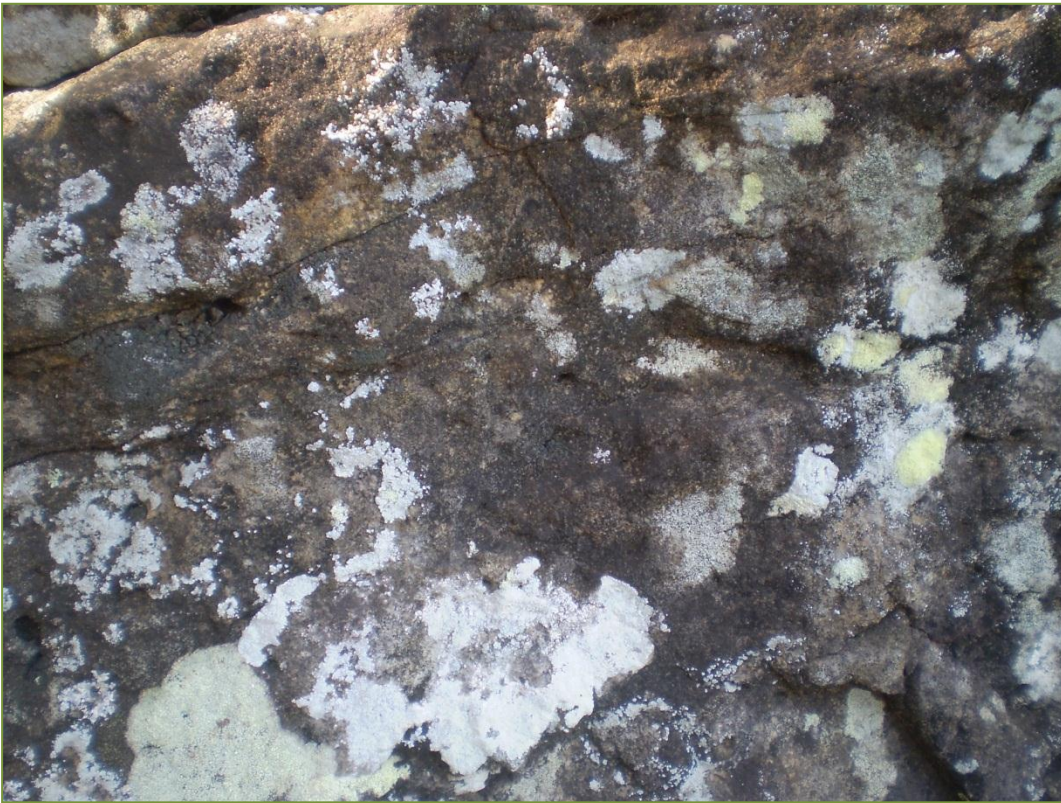
Geology code and rock types: Jlp - cross-bedded quartzose sandstone, sublabilite lithic sandstone, siltstone

Site 34 Rock surface
