**Compressor Site HCS-04  
Ecological Assessment  
Fairview Gas Fields  
Santos**

**Report ref:**  
221708-001  
1 June 2011  
Revision 1

Santos Document No: 0020-GLNG-4-1.3-0027 rev0

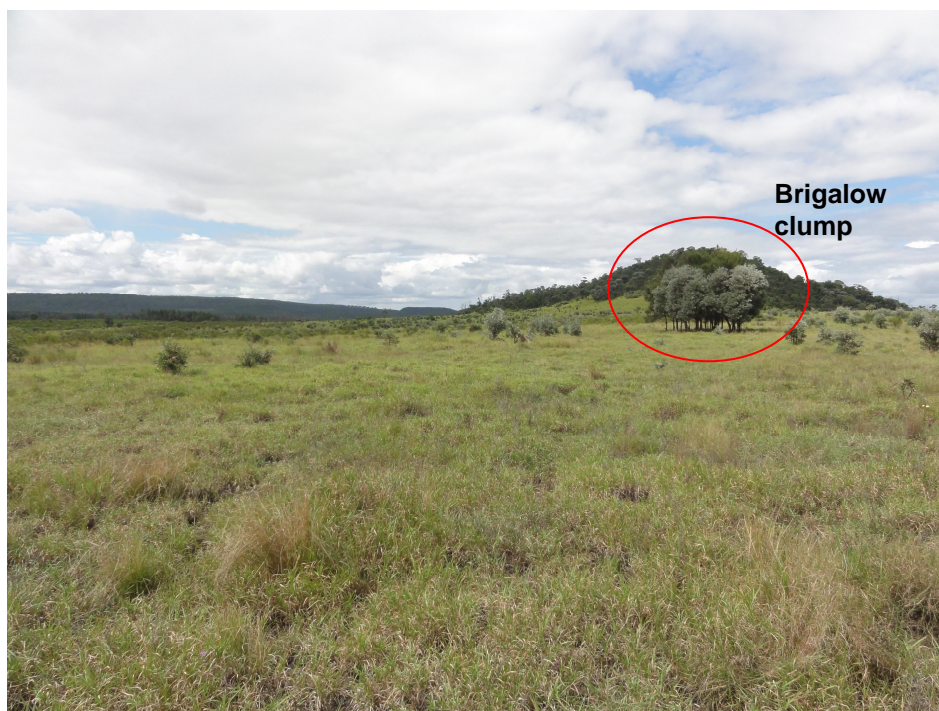
**Figure 3-3: Typical vegetation at Fairview Permanent Camp**

The camp site is very low in species richness and mainly consists of Buffel grass and regrowth Brigalow, very few other species occurred at this site with a total of only 22 species observed. Most of the Brigalow regrowth is less than 1.5m tall with the exception of one retained shade clump just outside the disturbance area which was approximately 4m tall (see **Figure 3-3**).
