**Roma Ecological Assessment
Report – Lot 2 RP858912
Santos Ltd**

Report ref:
221708-001
21 July 2011
Revision 2

Santos Document No: 0020-GLNG-4-1.3-0058 rev0

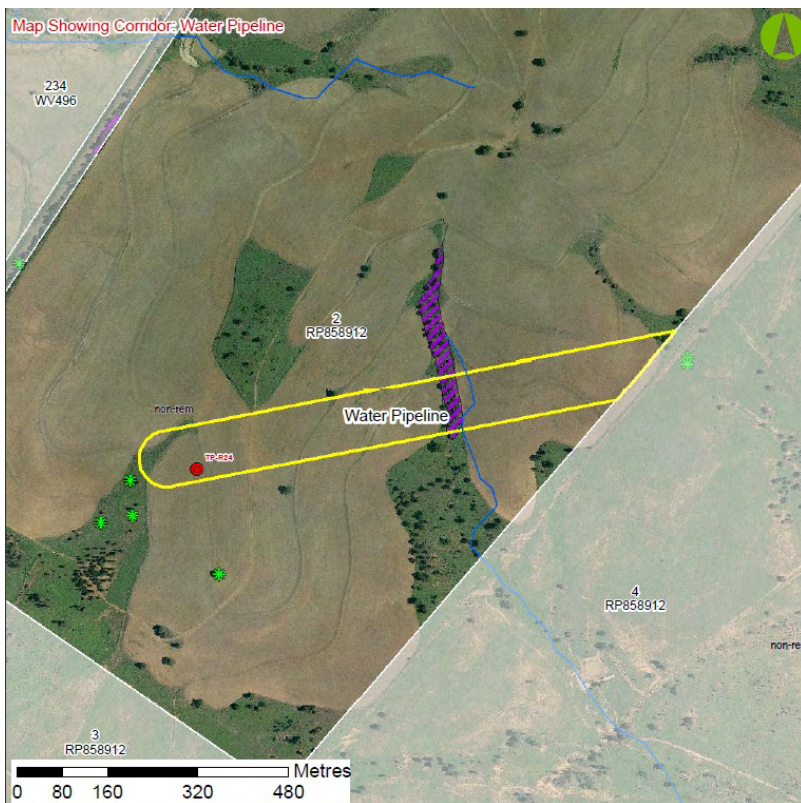
Figure 3.1 The proposed water pipeline corridor in Lot 2 RP858912

The water pipeline corridor heads in a west-south-west direction across lot 2 (RP858912) and ends at well pad RM08-17 and TP-R24 in the southern portion of Lot 2. The water pipeline corridor and associated pads RM08-17 and TP-R24 can be seen in Figure 3.1, Figure 3.2 and Figure 3.3 respectively.

The majority of the corridor has been subjected to severe disturbance in the form of extensive clearing and various agricultural practices. Grazing was evident at the time of surveys; however cropping was the main form of disturbance. An access road traverses part of the corridor.

However June surveys detected the presence of *Acacia harpophylla* (Brigalow) occurring within the creek-line intersecting the corridor. This community is listed as an endangered community under the EPBC Act. This community is classified as a 'Category B' ESA. This community was found to be present across the entire width of the corridor at this location.

Parts of the corridor exhibited signs of severe erosion, due from water run-off from cropped areas.

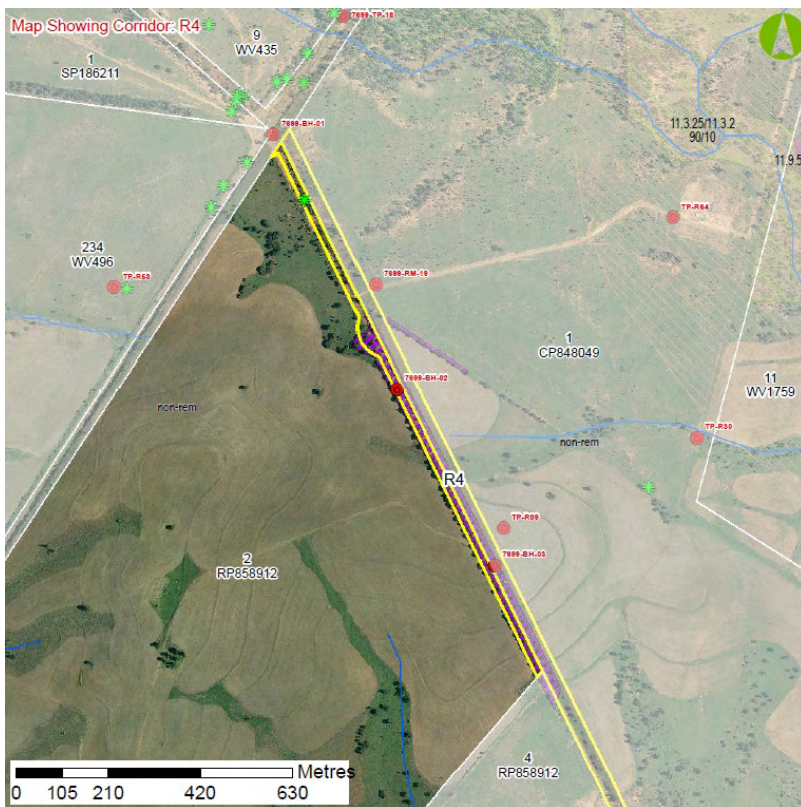
Figure 3.4 Proposed corridor R4 within Lot 2 RP858912

Corridor R4 runs south-east along the northern boundary of Lot 2 RP858912 along the Bend Road. This corridor is only partially located within corridor R4, and the remainder will be assessed in the appropriate report (Lot 1 CP848049). Included in this assessment are well pads 7699-BH-03, 7699-BH-02 and partial areas of TP-R09 and 7699-RM-19. The proposed corridor R4 and associated pads 7699-BH-02, 7699-BH-03, TP-R09 and 7699-RM-19 can be seen in Figure 3.4, Figure 3.5, Figure 3.6, Figure 3.7, and Figure 3.8 respectively.

The majority of Lot 2 has been cleared for cultivation; however corridor R4 is situated along the roadside which still contains scattered canopy trees. The location of the corridor in relation to the road and to the cultivated area indicates that the area is still highly disturbed.

Acacia harpophylla (Brigalow) which is listed under the EPBC Acts as endangered community occurs along the road side vegetation along the road side vegetation
