Roma Ecological AssessmentReport ref:<br/>221708-001Report – Lot 234 WV49621 July 2011Santos LtdRevision 2

Santos Document No: 0020-GLNG-4-1.3-0057 rev0

Santos Lot 234 on WV496

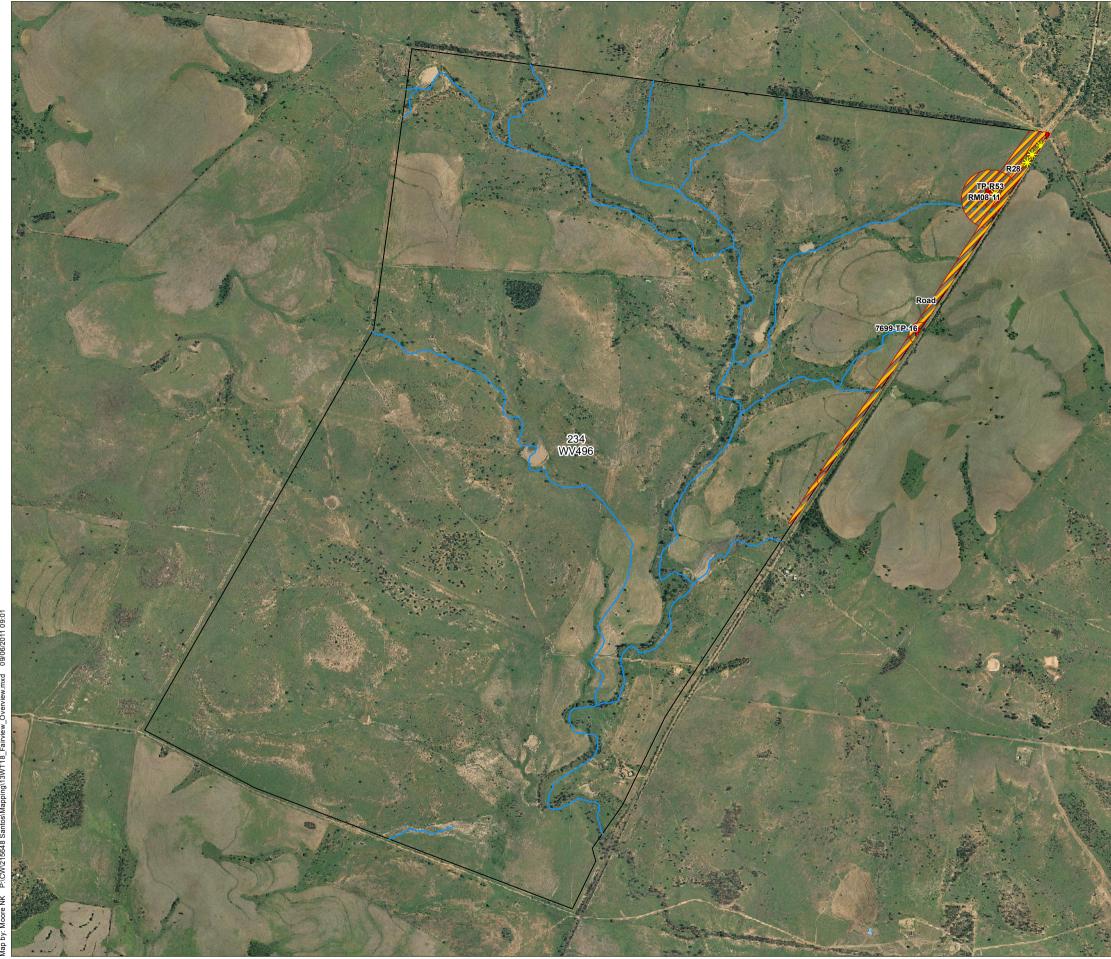
This report is specific to the proposed development areas listed below and shown in Figure 1:

- Pipeline corridor R28,
- Geotechnical survey locations situated within the above corridors and shown in Figure 1
- Road corridors.

These areas are collectively referred to as the 'proposed development area', and are located entirely within Lot 234 WV496. Note that the subject of this report is solely related to Lot 234 WV496. Where survey areas overlap additional properties, these sites will be further addressed in the report relevant to those properties/lots.

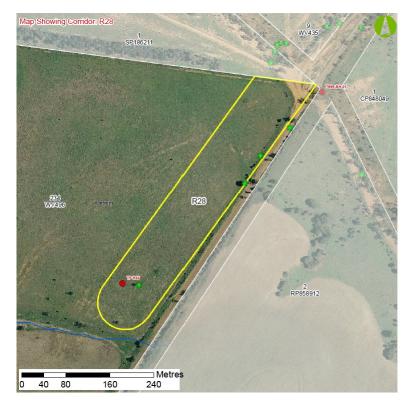
Figure 3.1 Proposed corridor R28 within Lot 234 WV496

Corridor R28 is located within historically cleared land that is currently being used for grazing. Salt Bush Road runs on the eastern boundary of this lot and intersects the corridor at the junction of Salt Bush Road and The Bend Road. TP-R53 and RM08-11 are associated with corridor R28 and will be included in this assessment. Corridor R28 and pads TP-R53 and RM08-11 can be seen in Figure 3.1, Figure 3.2 and Figure 3.3 respectively.

No RE's are mapped within this corridor, due to its cleared nature. The only remnant vegetation remaining within this corridor is on the western edge of Salt Bush Road.

No ESAs occur within the corridor; however an ESA occurs within 1 km to the north-west of the corridor.

Due to the highly cleared nature of this corridor, the vegetation is ground species dominated. Pasture species such as *Pennisetum ciliare* (Buffel Grass) dominates this area with scattered patches of *Calotis lappulacea* (Yellow Burr Daisy), *Verbena tenuisecta* (Mayne's Curse) and *Sclerolaena birchii* (Galvanised Burr). Shrub species include scattered *Geijera parviflora* (Wilga) and *Capparis loranthifolia* (Nipan).

Due to the majority of this corridor having undergone extensive clearing, the habitat value is considered low. However, the remaining vegetation along Salt Bush Road is considered to be of high habitat value, as it provides one of the few remaining fauna corridors in the area. A complex vegetation structure, fallen timber and the presence of larger tree species also supports this high value.

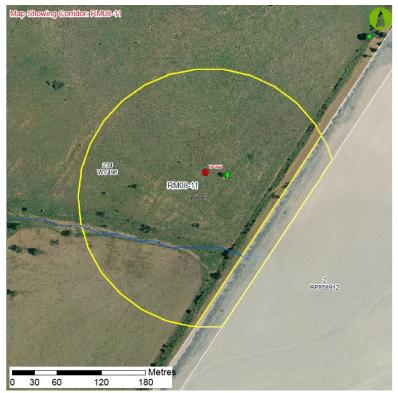
Figure 3.3 RM08-11 within Lot 234 WV496

A stream order 1 water course intersects RM08-11. At the time of surveys this water course was dry.

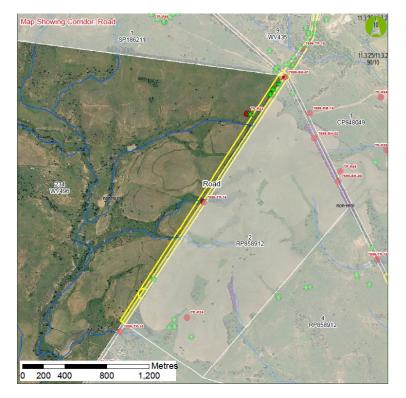
Figure 3.4 Proposed road corridor in Lot 234 WV496

The road corridor runs in a northern direction along the eastern edge of Lot 234 (WV496). The majority of the road corridor is situated within the limits of the existing Salt Bush Road corridor, and partially within Lot 2 (RP858912). Associated pads within this corridor are 7699-TP-16 and RM08-11 (partial). Both of these pads and part of the road corridor have been addressed in the Lot 2 RP858912 report. The road corridor and pads 7699-TP-16 and RM08-11 can be seen in Figure 3.4, Figure 3.5 and Figure 3.6 respectively.

The road corridor and associated well pads are situated in an existing road corridor and as such disturbance is high. A thin strip of vegetation is present alongside the road, however this varies in thickness. The eastern and western edges of the road corridor and associated pads are located within cultivated land.

There is no RE mapping available for this corridor as the corridor is situated within cultivated land, with only small patches of road side vegetation present.

There are no Mapped ESAs within the corridor; however the nearest ESA is approximately 1 km north east of the corridor.

Two stream order 1 water courses intersect the road corridor. Both were dry at the time of surveys.

This corridor is located within roadside vegetation which is made up of a number of native species. Canopy species present include *Acacia harpophylla* (Brigalow), *Casuarina cristata* (Belah) and *Eucalyptus populnea* (Poplar Box). Mid-storey species include *Acacia leiocalyx* (Black Wattle), *Geijera parviflora* (Wilga), and *Canthium oleifolium* (Hatstand). Ground cover species are a mixture of native and introduced species including *Themeda triandra* (Kangaroo Grass), *Sporobolus creber* (Western Rats Tail Grass), and *Bothriochloa bladhii subsp. Bladhii* (Forest Blue Grass). Scattered mature *Opuntia tomentose* (Velvety Tree Pear) are present throughout the corridor.

The vegetation present alongside the road and within the corridor represents moderate to high habitat value. This is due to the presence of some vegetative structure, fallen timber and dense vegetation in parts.
