**Roma Ecological Assessment
Report – Lots 585 and 588 on
WV394
Santos Ltd**

Report ref:
221708-001
20 July 2011
Revision 1

Santos Document No: 0020-GLNG-4-1.3-0051 rev0

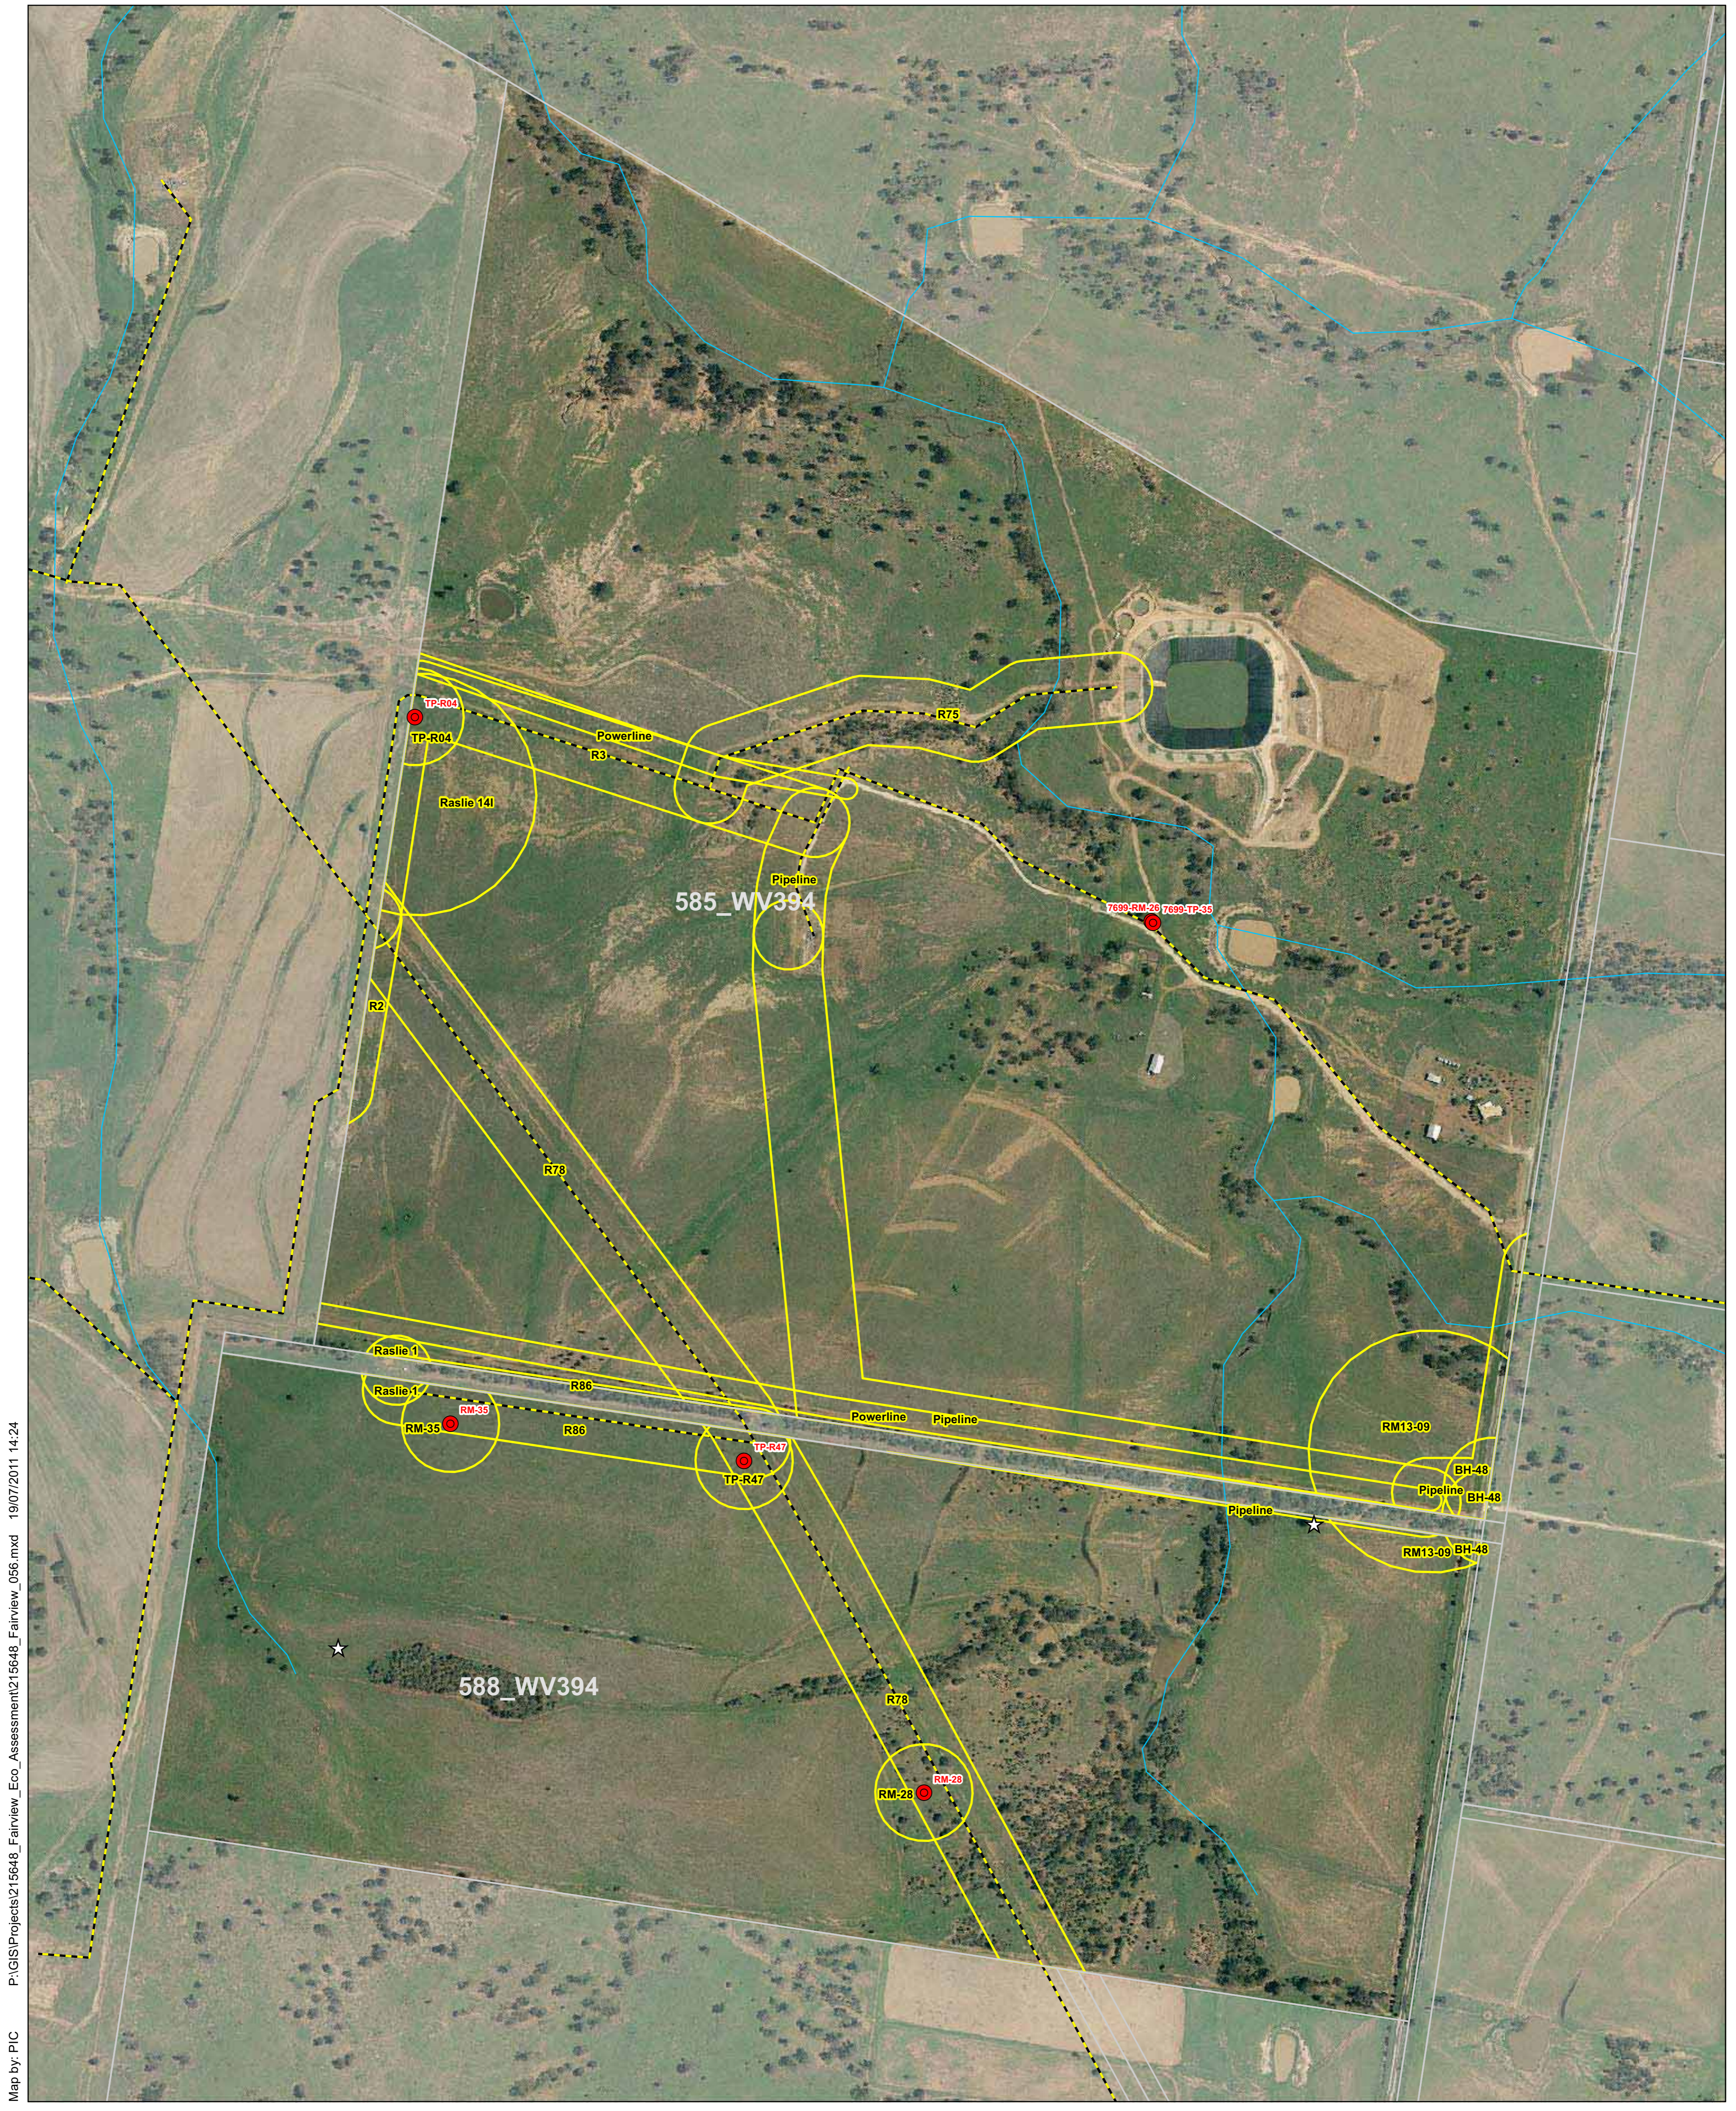
Figure 1-1: Location of Proposed Pipeline Corridors Investigated

This report is specific to the proposed development areas listed below and shown in Figure 1.1:

- Pipeline corridors R2, R3, R17, R75 and R78
- Well pads Raslie 14I and RM13-09
- Geotechnical survey locations situated within the above corridors and shown in Figure 1.1

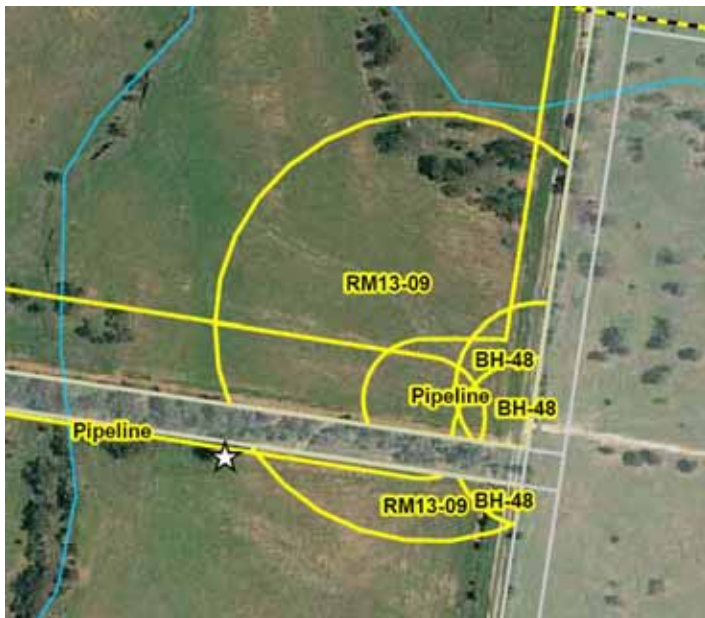
Figure 1.2. Aerial Photograph of RM13-09

The proposed well pad is located on Lot 585 on WV394 (Figure 1.1 and Figure 1.2). The site is generally flat, with two ephemeral drainage lines located in proximity (one to the north and one to the west) to the proposed area of disturbance. The proposed development area has been extensively disturbed as a result of previous vegetation clearing and heavy grazing by stock. The disturbance area is located to the north of the proposed powerline easement within the south-eastern corner of Lot 585 on WV394.

The development area is currently mapped as non remnant vegetation on the DERM RE mapping (Figure 1.1). There are no ESA's mapped within the development area.

The vegetation within the proposed development area has been previously cleared. The vegetation within the well pad is characterised by a dense ground cover layer which is dominated by native and exotic grass species including *Pennisetum ciliare* (Buffel Grass), and *Melinis repens* (Red Natal Grass). Canopy and shrub layers are absent from the proposed disturbance area.

The habitat value of the proposed development area is low overall, as it contains no canopy or mid storey vegetation.

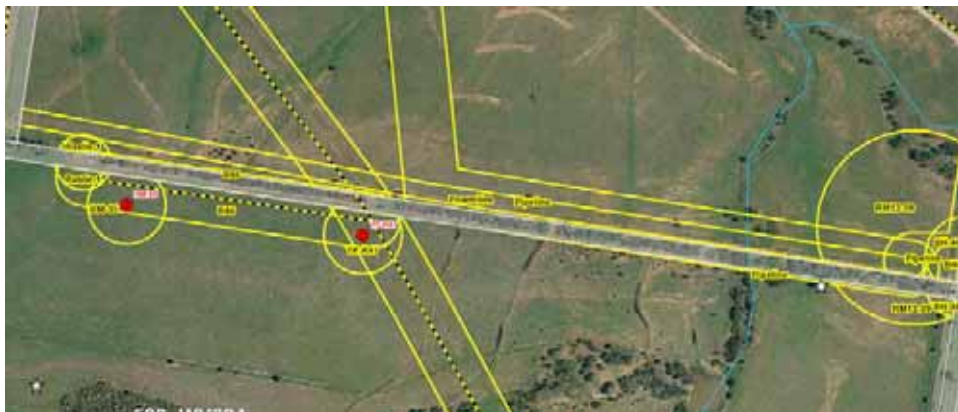
Figure 1.4. Aerial Photograph of Power Easement

The proposed power easement corridor is located along the property boundary of Lots 585 and 588 on WV394 (Figure 1.1 and Figure 1.4). A linear strip of mature, intact vegetation is contained within the proposed corridor. In addition, a single mapped, ephemeral drainage line (stream order 1) occurs within the eastern portion of the alignment (Figure 1.1). The site is gently undulating, and the soils are predominantly silty-sands. The northern portion of the proposed corridor has been extensively disturbed and an access track is located in this area. In addition, the understorey has and ground stratum within this corridor have been impacted by heavy grazing by stock..

There is one (1) watercourse mapped within the south-west section of the corridor (stream order 1). The land within the corridor is gently sloped towards, and is likely to drain into, this watercourse. This watercourse was not observed in flow at the time of the investigation (ie ephemeral watercourse).

The vegetation within the proposed corridor has been previously cleared, and an existing cleared access road traverses the corridor (along the property boundary fence). The vegetation within the corridor is characterised by a canopy of *Eucalyptus populnea* (Poplar Box) and *Casuarina cristata* (Belah) approximating 18 m in height, a relatively sparse mid stratum of *Eremophila mitchellii* (False sandalwood) and Acacia species and a relatively dense ground cover layer of native and exotic grass and forb species. Given the linear nature of this vegetation it does not meet the requirements of remnant vegetation under the provisions of the Queensland *Vegetation Management Act 1999* (VM Act)

Two (2) *Brachychiton populneus* were recorded within the proposed corridor – the location of this tree is provided in Table 3.1 and in Figure 1.1. This species is a Type A restricted plant under the NC Act.

The habitat value of the proposed corridor is low overall, as it is linear in nature and contains limited woody vegetation and has been disturbed by grazing stock, previous vegetation clearing and the invasion of exotic pasture species. Species utilising resources in this area are most likely to be limited to common, generalist species that are able to adapt to significant habitat disturbances.

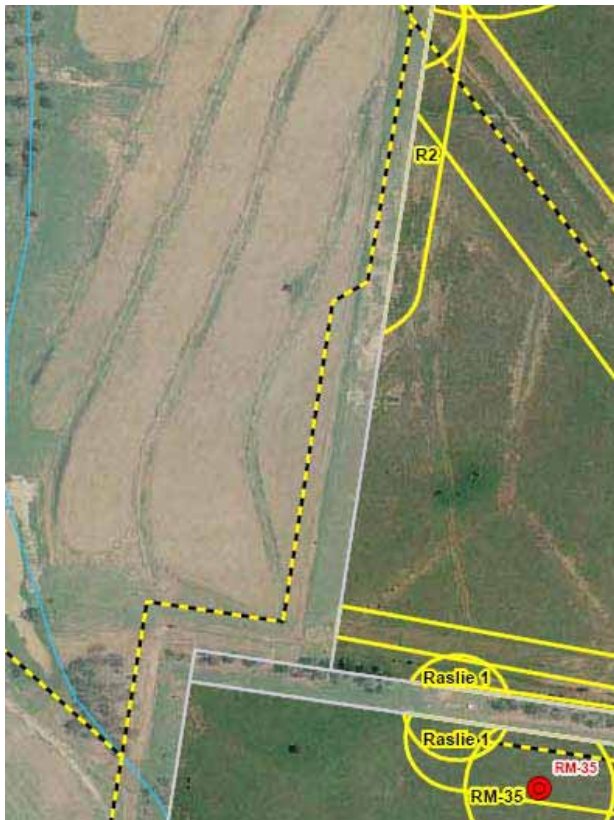
Figure 1.5. Aerial Photograph of R2

The proposed corridor is located on both Lot 585 and 588 on WV394 and is located along the north-western portion of Lot 588 and the western boundary of Lot 585 (Figure 1.1 and Figure 1.5). The proposed disturbance area is characterised by a gently undulating landform and the soils are predominantly silty-sands. The proposed development area has been extensively disturbed as a result of previous vegetation clearing and heavy grazing by stock. An access track also runs the length of this corridor along the respective property boundary.

The vegetation within the proposed disturbance area has been previously cleared. The vegetation within this area is characterised by a dense ground cover layer which is dominated by native and exotic grass species including *Pennisetum ciliare* (Buffel Grass), and *Melinis repens* (Red Natal Grass). Canopy and shrub layers are generally absent from the proposed disturbance area.

The habitat value of the proposed development area is low overall, as it contains no canopy or mid storey vegetation.

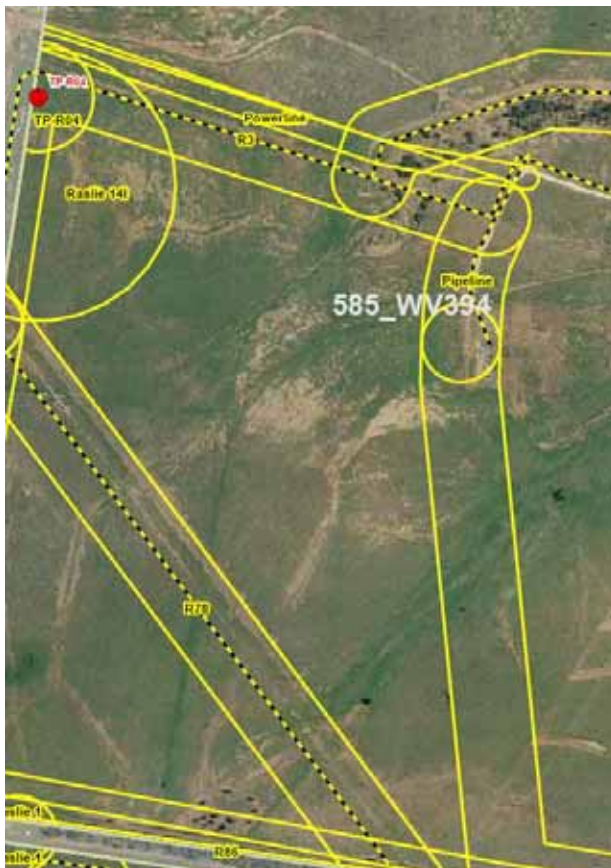
Figure 1.6. Aerial Photograph of R3

The proposed corridor is located on Lot 585 on WV394 and is located along the central and western portions of the lot (Figure 1.1 and Figure 1.6). The site is gently undulating, and the soils are predominantly silty-sands. Two (2) unmapped drainage lines intersect the proposed corridor within the central portion of the property. The proposed corridor has been extensively disturbed as a result of previous vegetation clearing and heavy grazing by stock. Access tracks are present along much of the corridors length.

The land within the corridor is gently sloped towards the unmapped drainage lines, and is likely to drain into these areas. No water was present within these drainage lines at the time of the investigation (ie ephemeral watercourse).

The canopy layer is dominated by sporadic patches of *Acacia harpophylla* (Brigalow) and the occasional *Eucalyptus populnea* (Poplar Box) which covers approximately 2% of the corridor area. Canopy species were generally 5 m in height. The shrub layer is generally absent from this corridor (Figure 1.1).

The habitat value of the proposed corridor is low overall, as it contains limited woody vegetation and has been extensively disturbed by grazing stock, previous vegetation clearing and the invasion of exotic pasture species. Species utilising resources in this area are most likely to be limited to common, generalist species that are able to adapt to significant habitat disturbances.

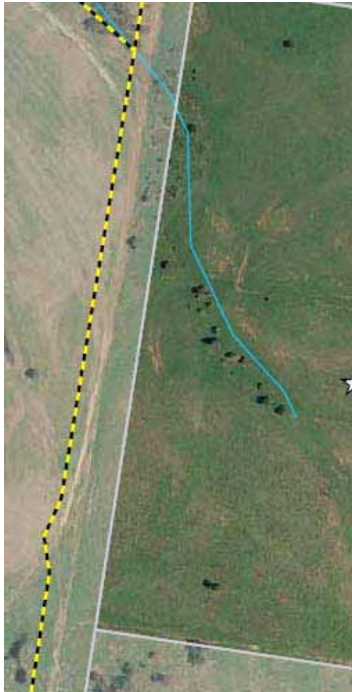
Figure 1.7. Aerial Photograph of R17

The proposed corridor is located on Lot 588 on WV394 and is situated along the western boundary of the property (Figure 1.1 and Figure 1.7). The landform contained within the proposed corridor is gently undulating, with an ephemeral drainage line (stream order 1) bisecting the corridor in its northern section. The site is gently undulating, and the soils are predominantly silty-sands. The proposed corridor has been extensively disturbed as a result of previous vegetation clearing and heavy grazing by stock. An access track which follows the property boundary runs the length of the corridor.

The drainage line contained water at the time of investigation; however this was as a series of pools. Water was not flowing during the current investigation

Much of the vegetation within the proposed corridor has been previously cleared, however vegetation along the unmapped drainage line was characterised by scrubby regrowth dominated by *Citrus glauca* (Native lime). Other shrub species present include *Acacia harpophylla* (Brigalow), *Alectryon diversifolius* (Scrub Bonaree) and *Eremophila mitchellii* (False Sandalwood). Scrubby regrowth approximated 2 m to 4 m in height.

The habitat value of the proposed development area is low overall as vegetation contained within this corridor has been subject to high levels of anthropogenic disturbance.

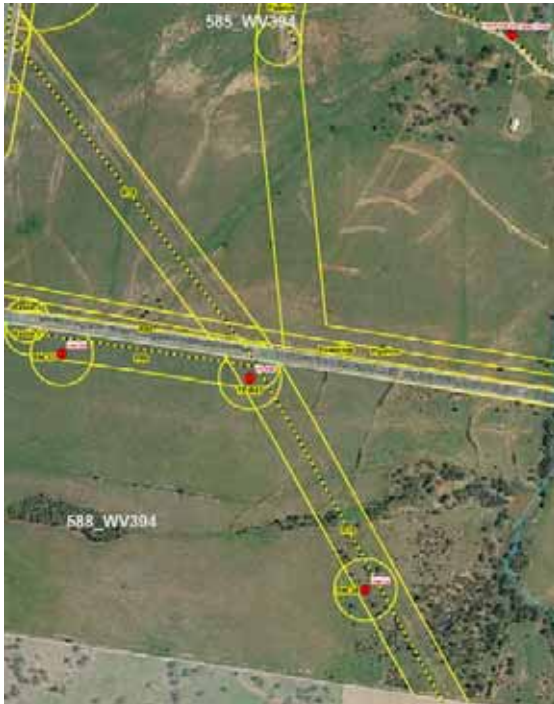
Figure 1.9. Aerial Photograph of R78

The proposed corridor is located on both Lot 585 and 588 on WV394 and is moves from lot 585 through and into lot 588 in an north-west, south-east direction (Figure 1.1 and Figure 1.9). Land contained within this corridor is gently undulating, and the soils are predominantly silty-sands. Two (2) unmapped drainage lines intersect the proposed corridor, one in the southern portion of Lot 585 and the other within the central portion of Lot 588 (Figure 1.1). The proposed corridor has been extensively disturbed as a result of previous vegetation clearing and heavy grazing by stock. Access tracks are present along much of the corridors length which follows an existing pipeline easement.

The land within the corridor is gently sloped towards the unmapped drainage lines, and is likely to drain into these areas. No water was present within these drainage lines at the time of the investigation (ie ephemeral watercourse).
