Project: Roma Ecological
Assessment Report – Lot 586 WV394

Prepared for: Santos Ltd

22 August 2011

Santos Document No: 0020-GLNG-4-1.3-0083 rev0

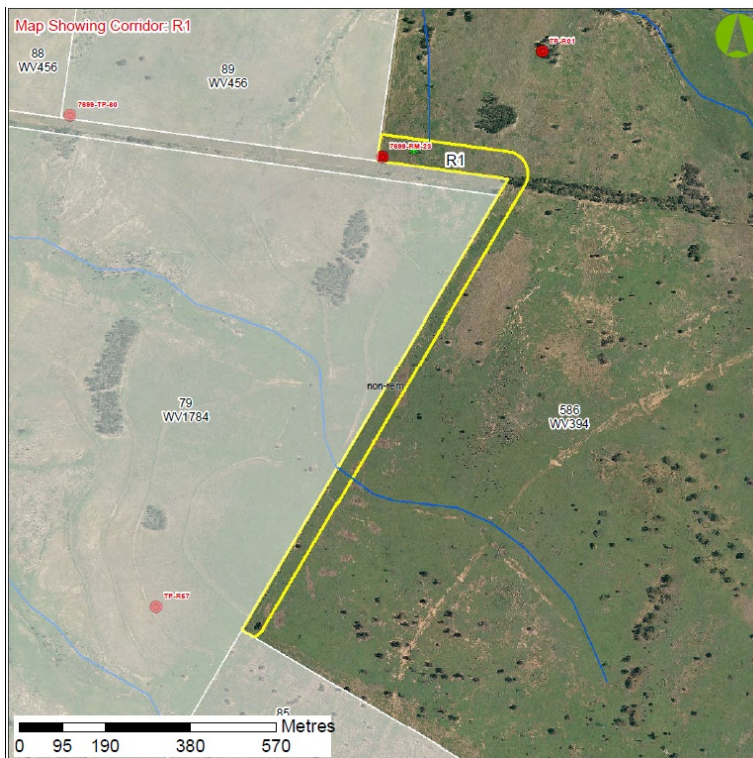
Figure 3.1 Aerial photograph and associated RE mapping of proposed corridor R1

There are no major tracks within the corridor or geo-tech. The proposed corridor intersects two watercourses (stream order 1) were dry at the time of the survey. The riparian vegetation associated with the watercourses has been heavily disturbed and fragmented. Corridor R1 and the associated geo-tech are illustrated in Figures 3.1 and Figure 3.2.

The landscape within corridor R1 has been previously cleared and disturbed as a result of grazing and other agricultural practices. The vegetation within the proposed development area is dominated by *Pennisetum ciliare* (Buffel Grass). Isolated native species including *Acacia excelsa* (Ironwood), *Atalaya hemiglauca* (Whitewood), *Canthium oleifolium* (Wild lemon) and *Geijera parviflora* (Wilga) are scattered across the proposed road corridor.

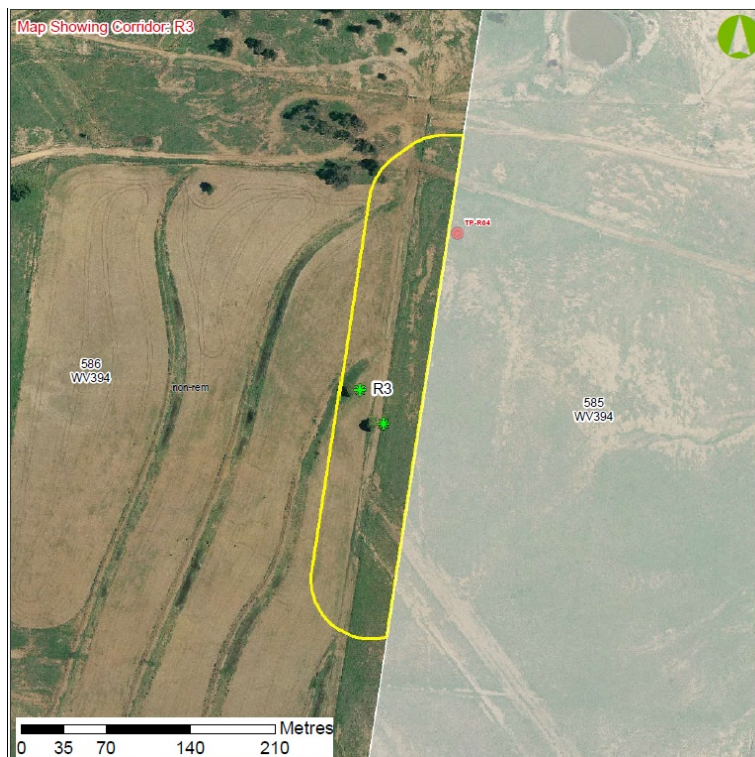
Figure 3.9 Aerial photograph and associated RE mapping of proposed corridor R3

There are no ESA's in proximity to the proposed disturbance area. There are no watercourses or tracks within the proposed disturbance area, corridor R3 and the associated geo-techs are shown in Figures 3.9 to Figures 3.11.

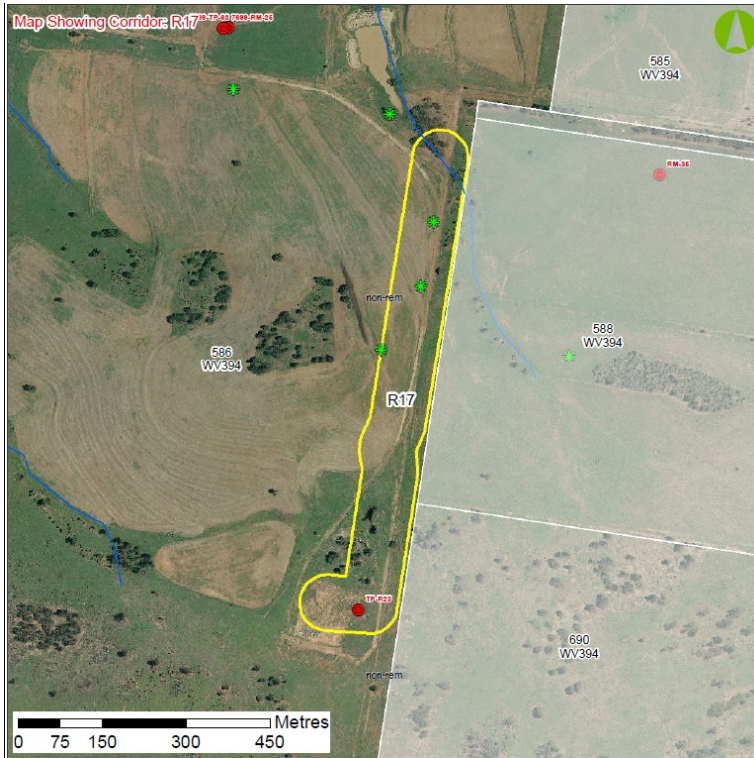
Figure 3.12 Aerial photograph and associated RE mapping of proposed corridor R17

There are no ESA's in proximity to the proposed disturbance area. There is one watercourse (stream order 1) in the north of the corridor that was dry at the time of surveying. The corridor follows a fence line and a small track, part of the corridor occurs within cultivated areas and in the south of the corridor there is an existing well site and a dam. Corridor R17 and the associated geo-tech are show in Figure 3.12 and Figure 3.13.

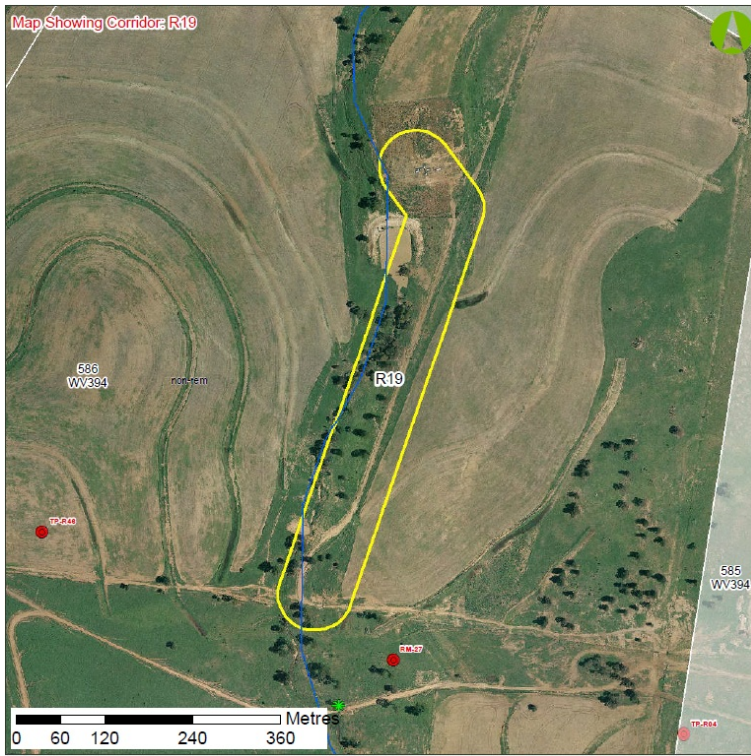
Figure 3.14 Aerial photograph and associated RE mapping of proposed corridor R19

There are no ESA's in proximity to the proposed disturbance area. There is one watercourse (stream order 1) that the corridor follows and was dry at the time of surveying. There is a constructed dam occurring part way along this watercourse. Corridor R19 is show in Figure 3.14.

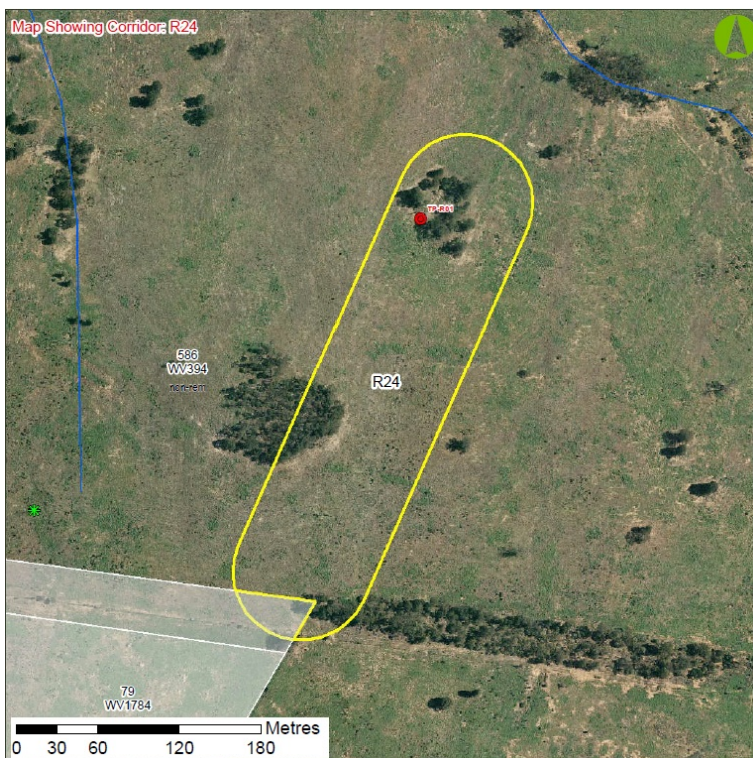
Figure 3.15 Aerial photograph and associated RE mapping of proposed corridor R24

There are no major tracks within the proposed disturbance area. The proposed corridor intersects two watercourses, one stream order 1 and the other stream order 2, both were dry at the time of the survey. The riparian vegetation associated with the watercourses has been heavily disturbed and fragmented. Corridor R24 and its associated geo-techs and road are illustrated in Figure 3.15 to Figure 3.18, the powerline is shown in Figure 3.29.
