**Roma Lot 7WV435 Ecological  
Investigation  
Santos**

**Report ref:**  
221708  
11 July 2011  
Revision 0

Santos Document No: 0020-GLNG-4-1.3-0064 rev0

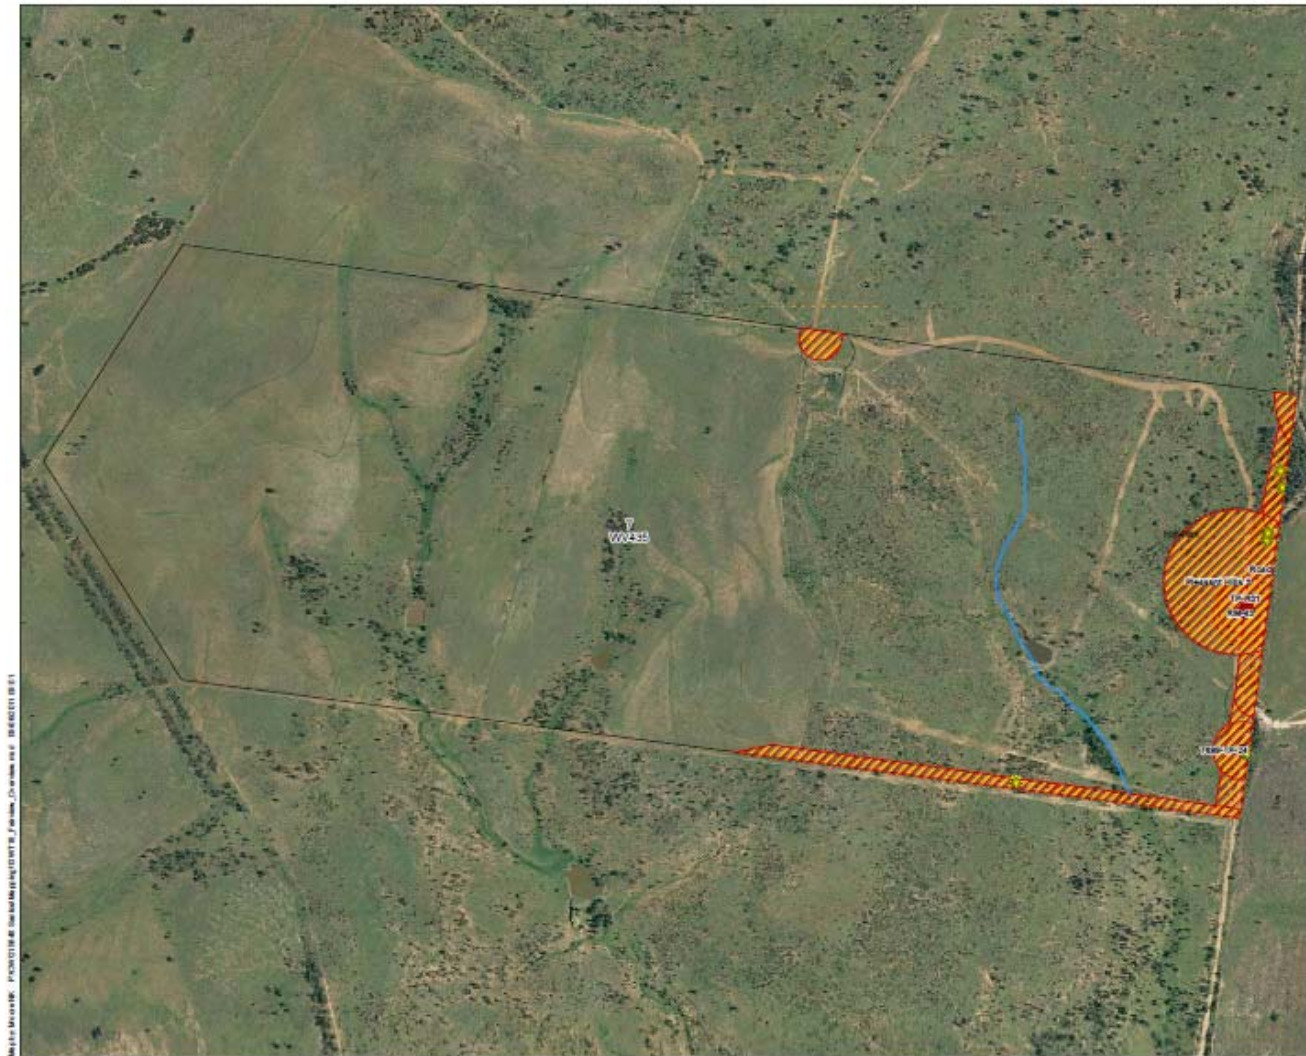
**Figure 1.1 Overview of proposed corridors and geotechnical locations that were ground-truthed on lot 7WV435**

This report is specific to the proposed development areas listed below and shown in Figure 1.1:

- Pipeline corridors R4, R39 and R69
- Geotechnical survey locations situated within the above corridors and shown in Figure 1.1
- A road corridor

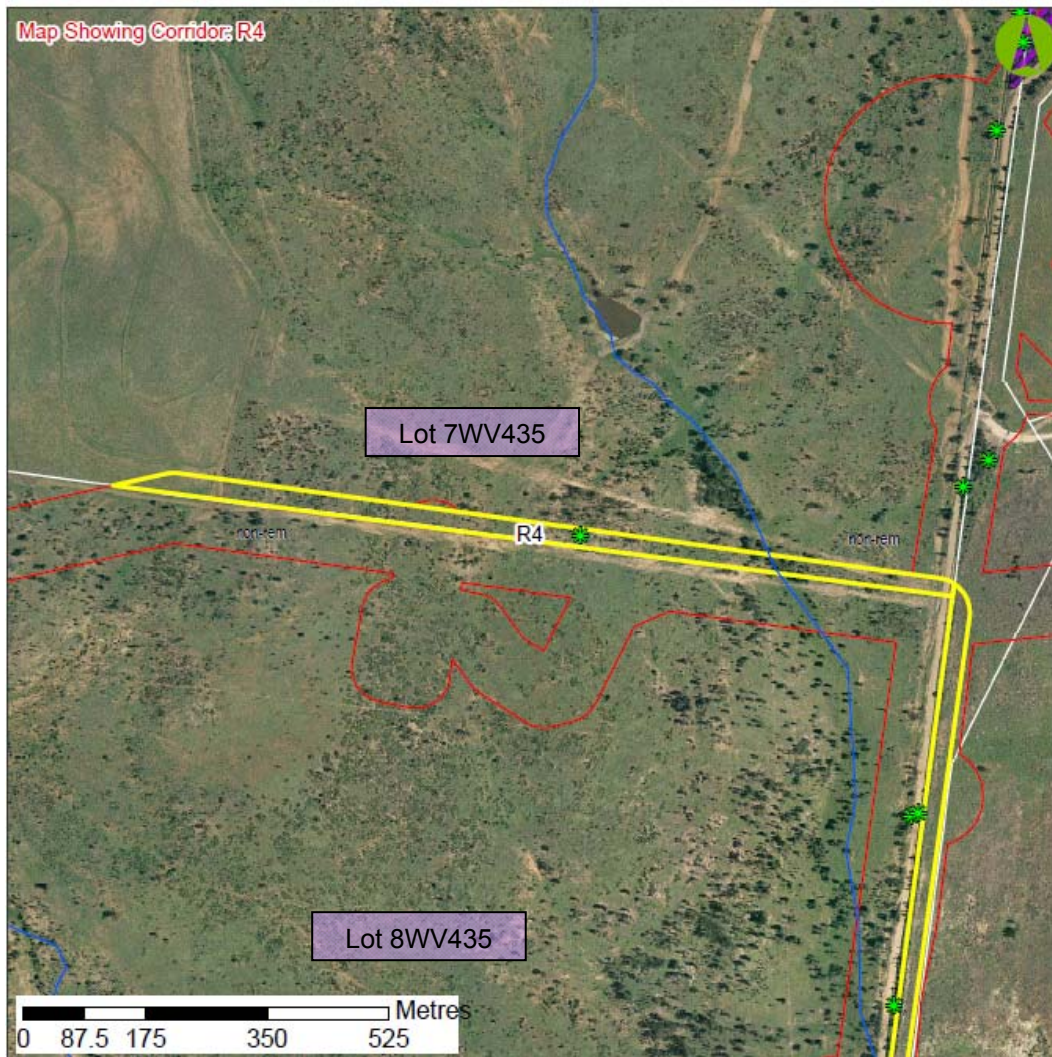
**Figure 3.1** Aerial photograph of proposed corridor R4 and associated geotechnical locations, with overlaid RE and ESA mapping

Corridor R4 traverses several lots (8WV435, 7WV435 and 9WV435 further south) as shown in Figure 3.1. Only the portion of corridor R4 on lot 7WV435 will be discussed in this report.

The entirety of corridor R4 on lot 7WV435 is mapped as non-remnant vegetation, which is correct.

No ESAs occur within the corridor and the nearest ESA is greater than 1 km distant.

One minor watercourse of stream order 2 traverses the corridor.

Mount Saltbush Road, which is a major access road for the area, adjoins the eastern end of corridor R4 on lot 7WV435. The southern boundary of the corridor is defined by a fence line which separates lot 7WV435 from lot 8WV435 to the south.

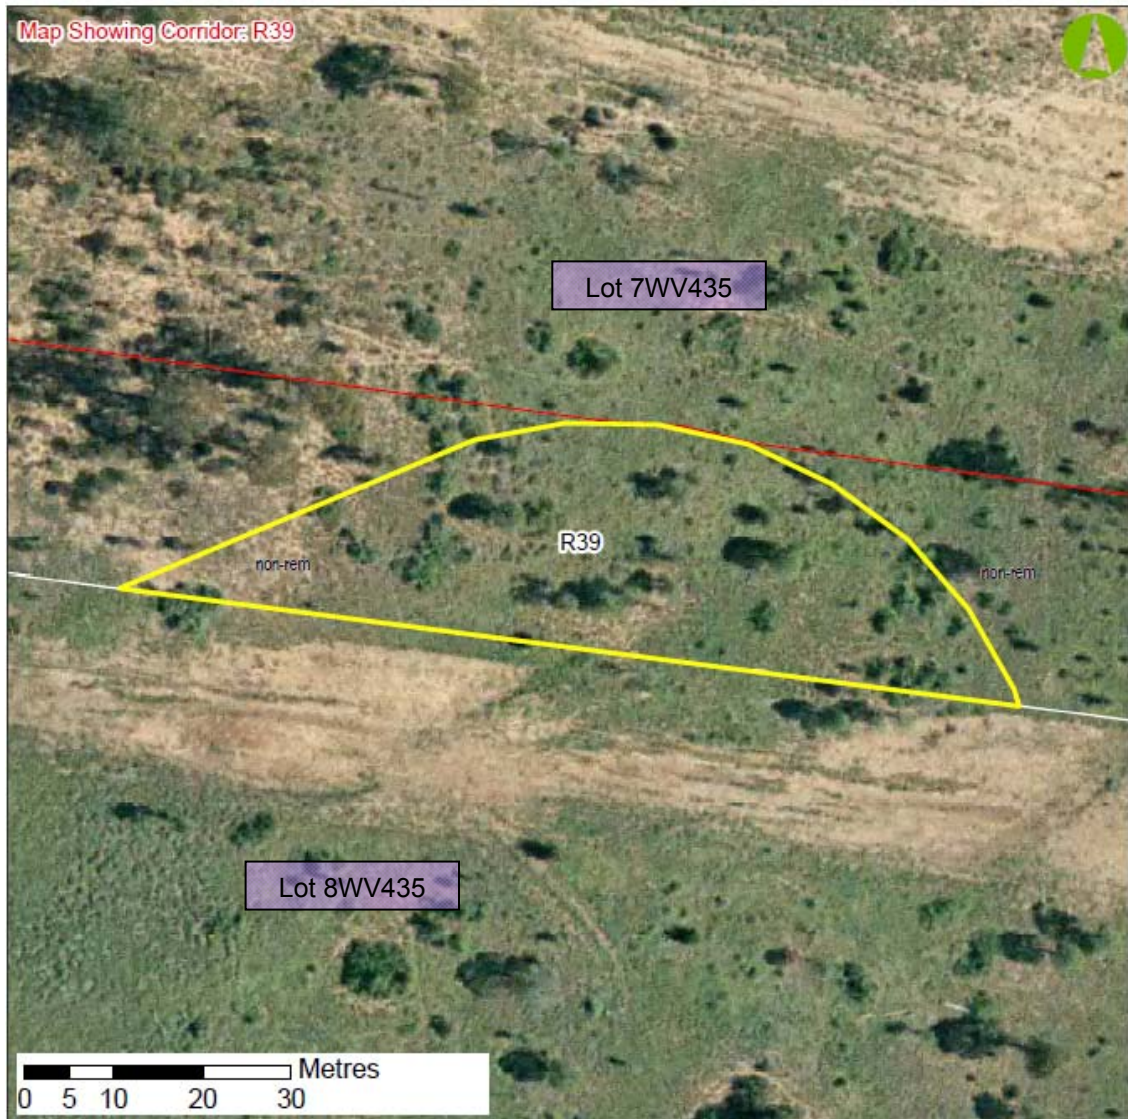
Figure 3.2 Aerial photograph of proposed corridor R39 with overlaid RE and ESA mapping

A small portion (25 m in length) of corridor R39 occurs on lot 7WV435, with the remainder on lot 8WV435. Only the portion on lot 7 will be discussed in this report.

Corridor R39 is mapped entirely as non-remnant vegetation, which is correct, as shown in Figure 3.2.

No ESAs occur within the corridor and the nearest ESA is greater than 1 km distant.

No watercourses occur within the corridor.

A fence line and access track adjoins the southern boundary of the portion of corridor R39 on lot 7WV435.

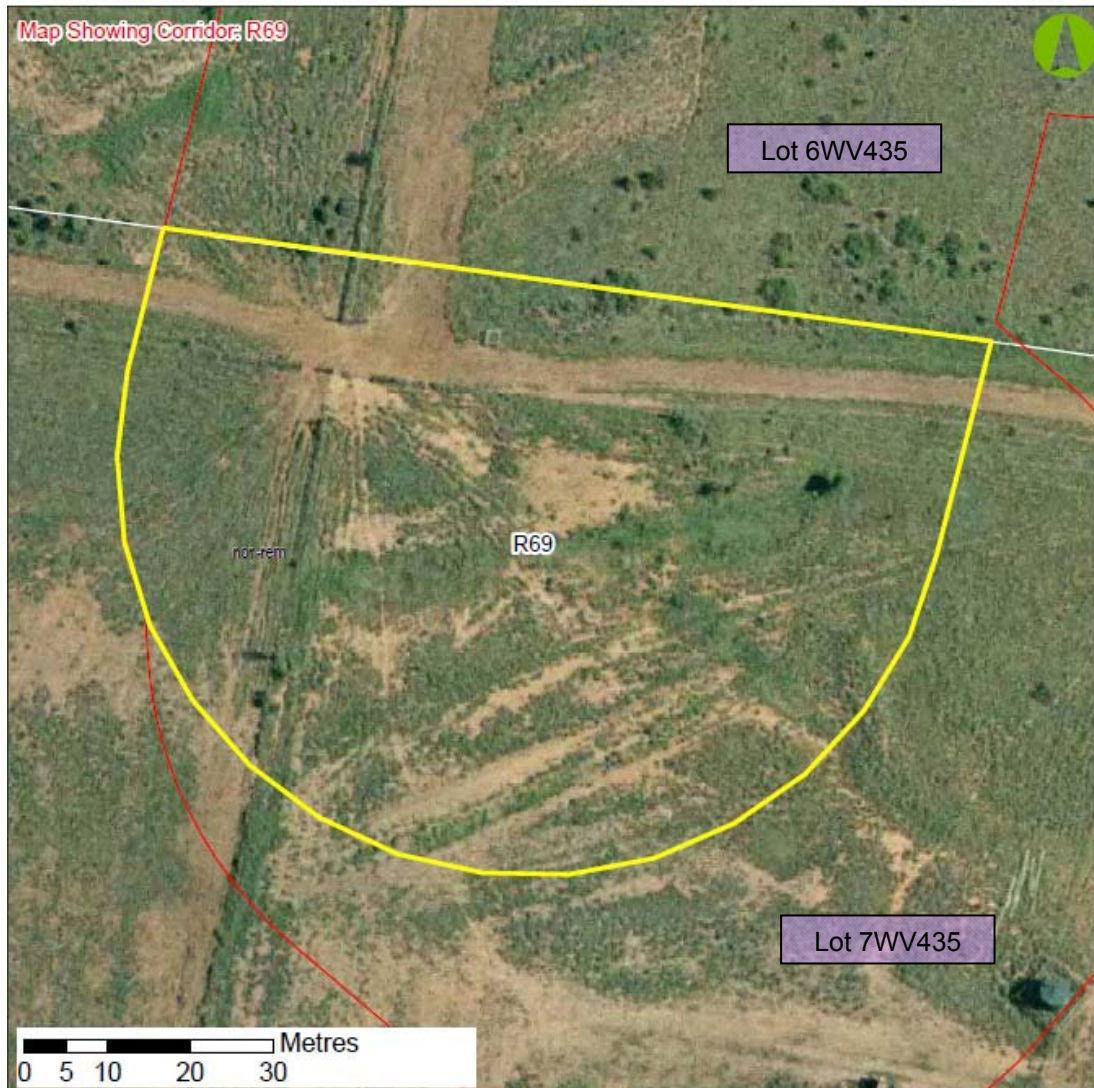
**Figure 3.3** Aerial photograph of proposed corridor R69 and associated geotechnical locations, with overlaid ESA and RE mapping

A small portion (70 m in length) of corridor R69 occurs on lot 7WV435, with the remainder on lot 6WV435. Only the portion on lot 7 will be discussed in this report.

The corridor portion is mapped entirely as non-remnant vegetation, as shown in Figure 3.3, which is correct.

No ESAs occur within the corridor, and the nearest ESA is greater than 1 km distant.

No watercourses occur in the proposed corridor, and a major access track crosses the northern end of the portion.
