**Roma Ecological Assessment
Report - Lots 22, 23 and 24 on
WV432
Santos Ltd**

Report ref:
221708-001
21 July 2011
Revision 2

Santos Document No: 0020-GLNG-4-1.3-0062 rev0

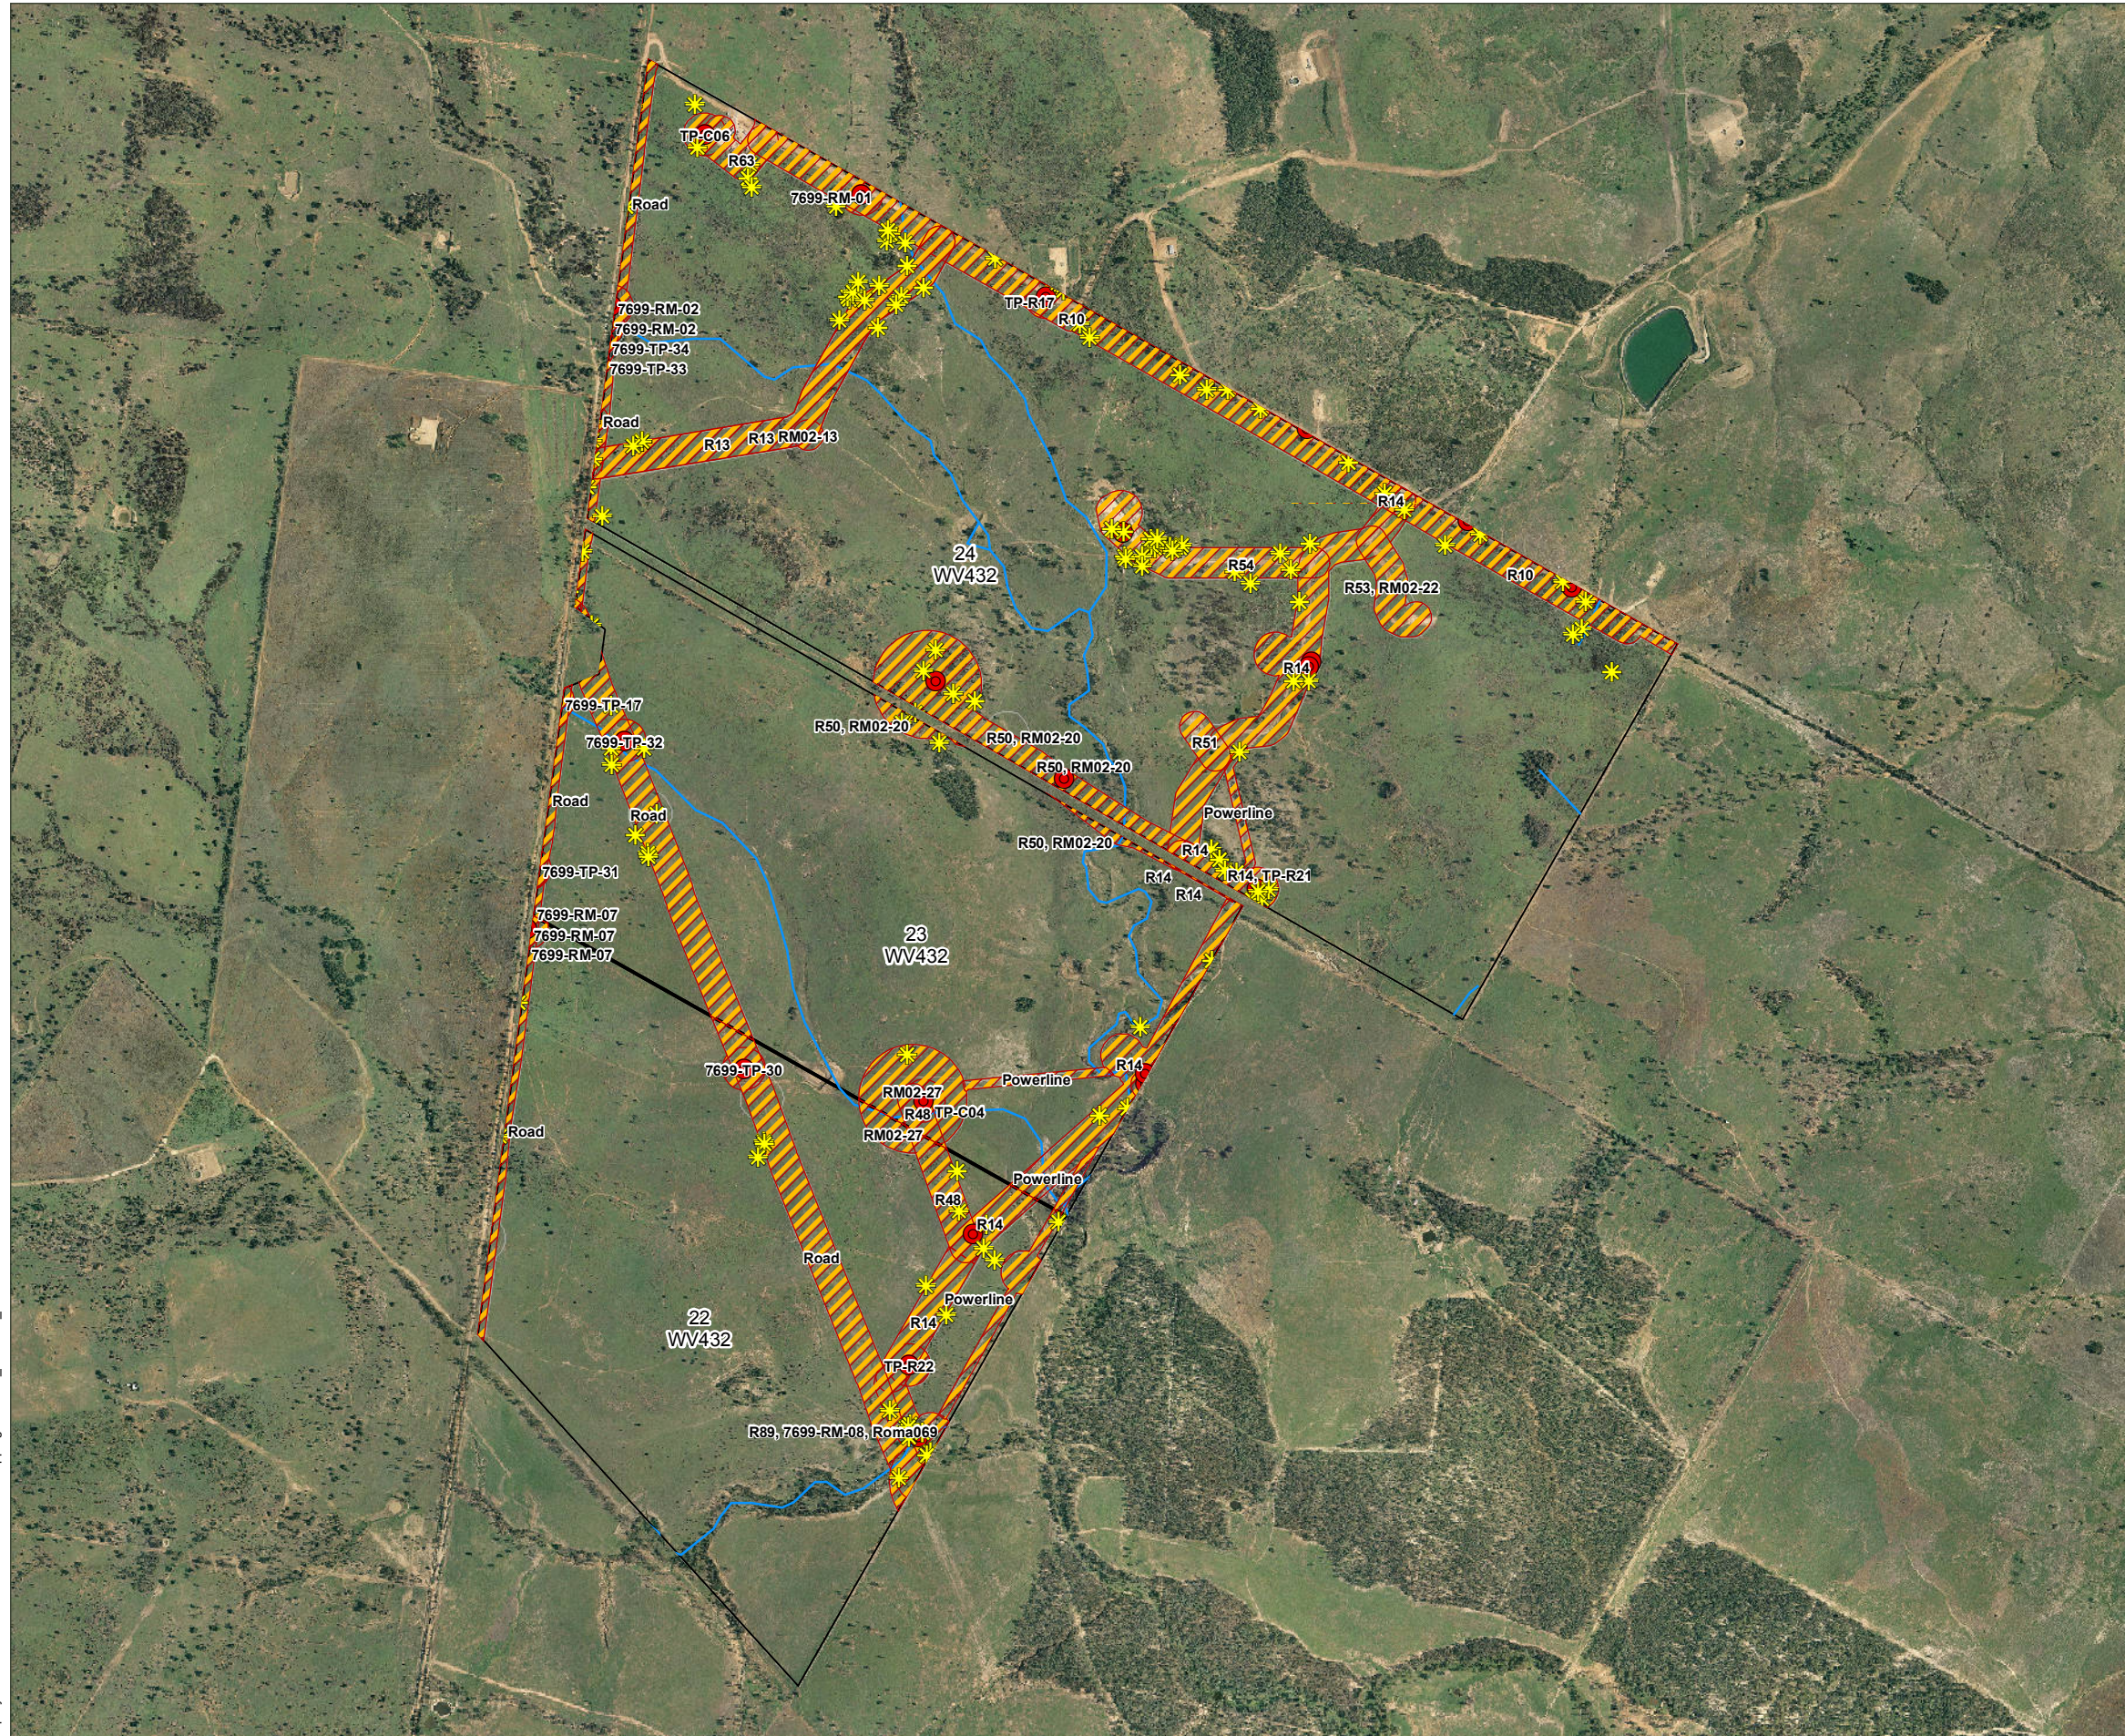
This report is specific to the proposed development areas listed below and shown in Figure 1.1:

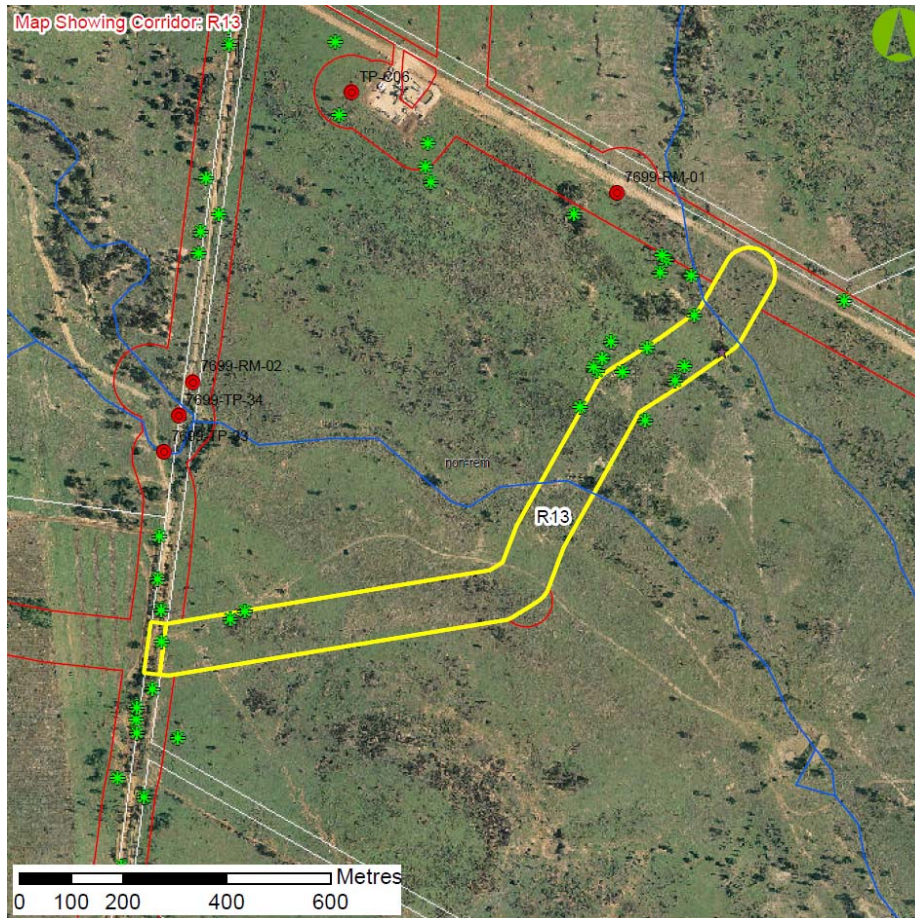
Two (2) watercourses bisect the north-eastern section of the corridor and are mapped as stream order 2 and a stream order 3 (Figure 3.2). Neither watercourse was recorded as in flow at the time of the survey, however the northern-most watercourse contained a series of disconnected pools.

A cleared strip of approximately 20 m width occurs along the majority of the proposed corridor length, which appears to have been recently cleared/maintained which may be associated within an existing water pipeline however this was unable to be confirmed on site.

Figure 3.2 Aerial photograph of proposed corridor R13 * - denotes the location of Type A species

A total of eight (8) Brachychiton species and one (1) *Cymbidium canaliculatum* (Black orchid) were recorded within the corridor – the locations of these species are outlined in Table 3-2 and in Figure 3-2. All of the species in 2 are Type A restricted plants under the NC Act. No species protected under the provisions of the EPBC Act were observed within the proposed corridor.

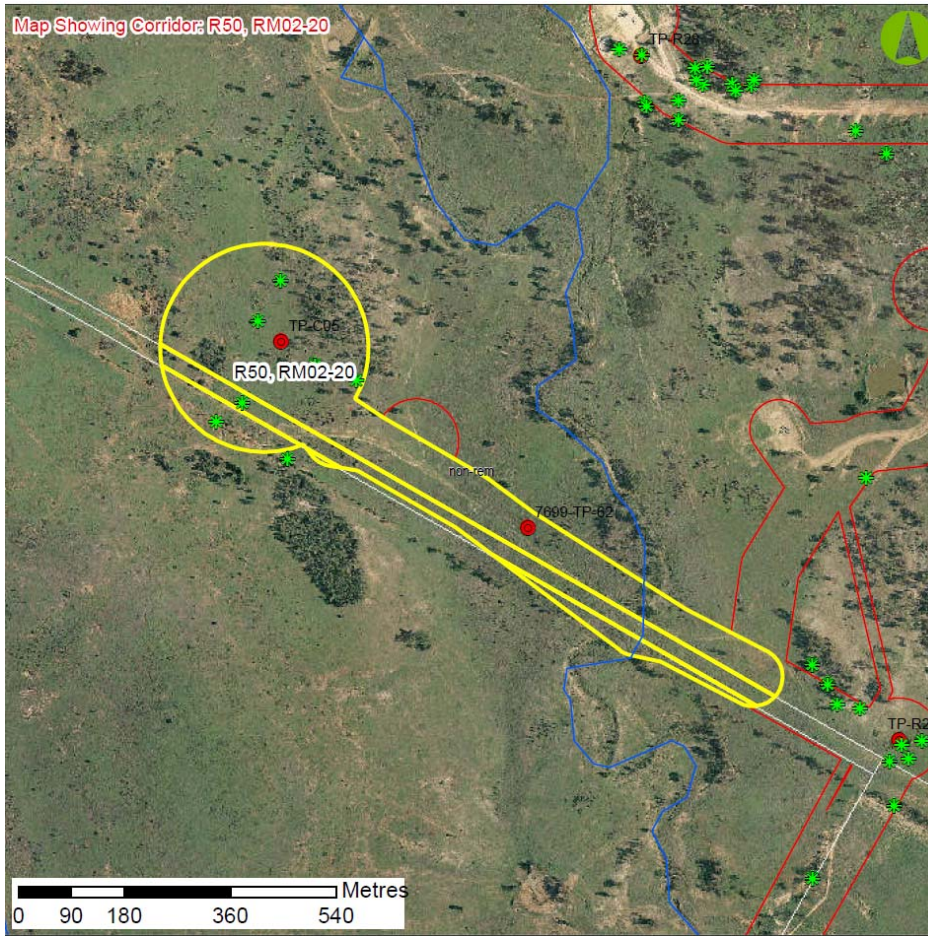
The corridor occurs across a mapped watercourse with a stream order of 3 which was evident during the field inspection.

The area is currently used for grazing domestic livestock and contained an existing access track.

Figure 3.5 Aerial photograph of proposed corridor R50 * - denotes the location of Type A species

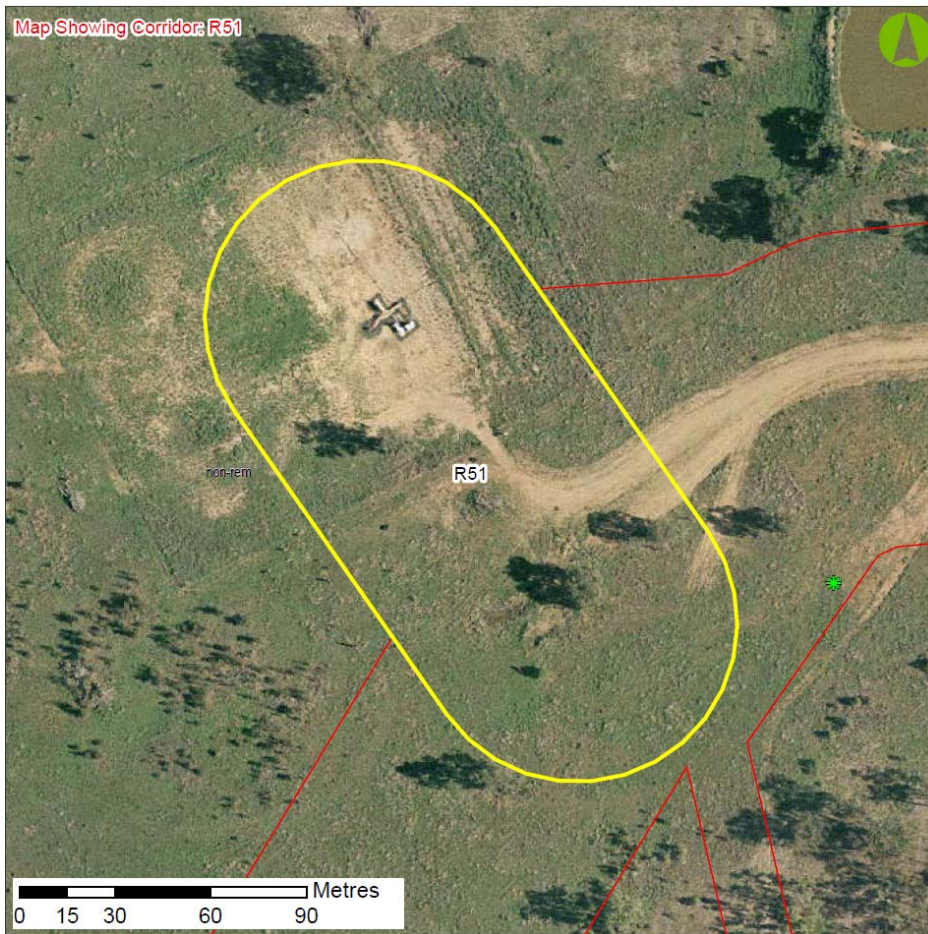
Corridor R51 is located on Lot 24 WV432 and is an existing well pad clearance of approximately 100 m in width and 115 m in length and lies adjacent to Corridor R14 on the western side of the corridor (refer Figure 3.6). Corridor R51 is almost devoid of vegetation except for native and exotic pasture grasses. There are no geotechnical investigation sites proposed within this corridor nor are there any watercourse crossings within this corridor.

Figure 3-6 Aerial photograph of proposed corridor R51

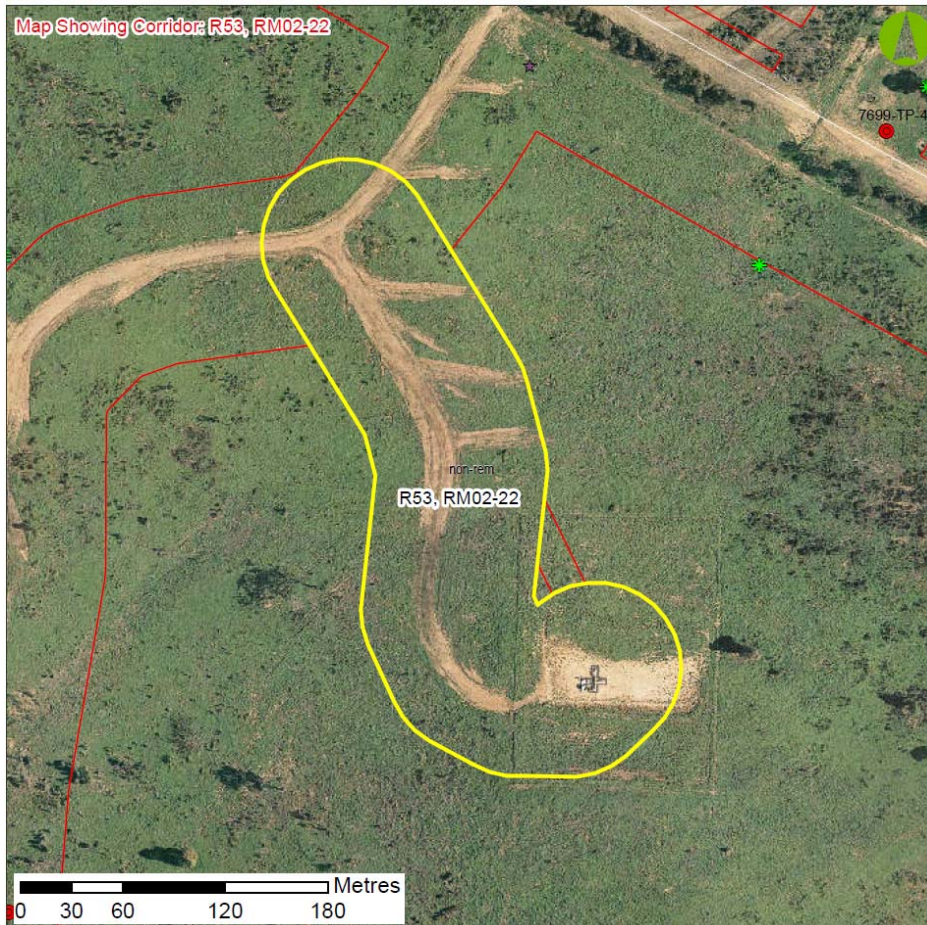
The proposed development area is currently mapped as non remnant on the DERM RE mapping. The area does not occur within any areas identified as ESA's, with the nearest mapped ESA located more than 1.8 km to the south of the corridor.

The corridor does not intersect any watercourses, with the nearest watercourse located approximately 500 m to the east.

Figure 3-7 Aerial photograph of proposed corridor R53

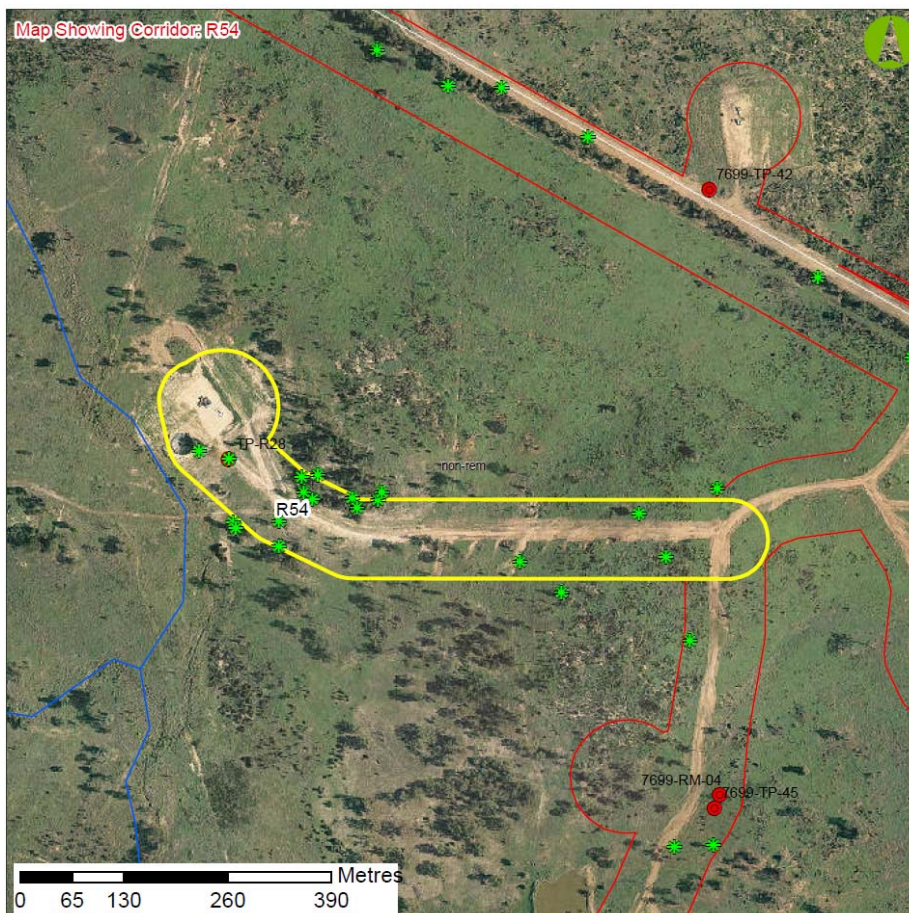
Corridor R54 is approximately 130 m in length and is located entirely in non-remnant vegetation on the RE mapping (refer Figure 3.8). The development area is not located in or within 1 km of any mapped ESA's. The nearest ESA to the corridor is approximately 2 km to the south and is an area of remnant 'Of concern' vegetation which is a 'Category C' ESA. Corridor R54 includes geotechnical location TP-R28.

A stream order 1 watercourse is mapped as occurring approximately 45 m from the proposed corridor and is not affected by Corridor R54.

Figure 3-8 Aerial photograph of proposed corridor R54 * - denotes the location of Type A species

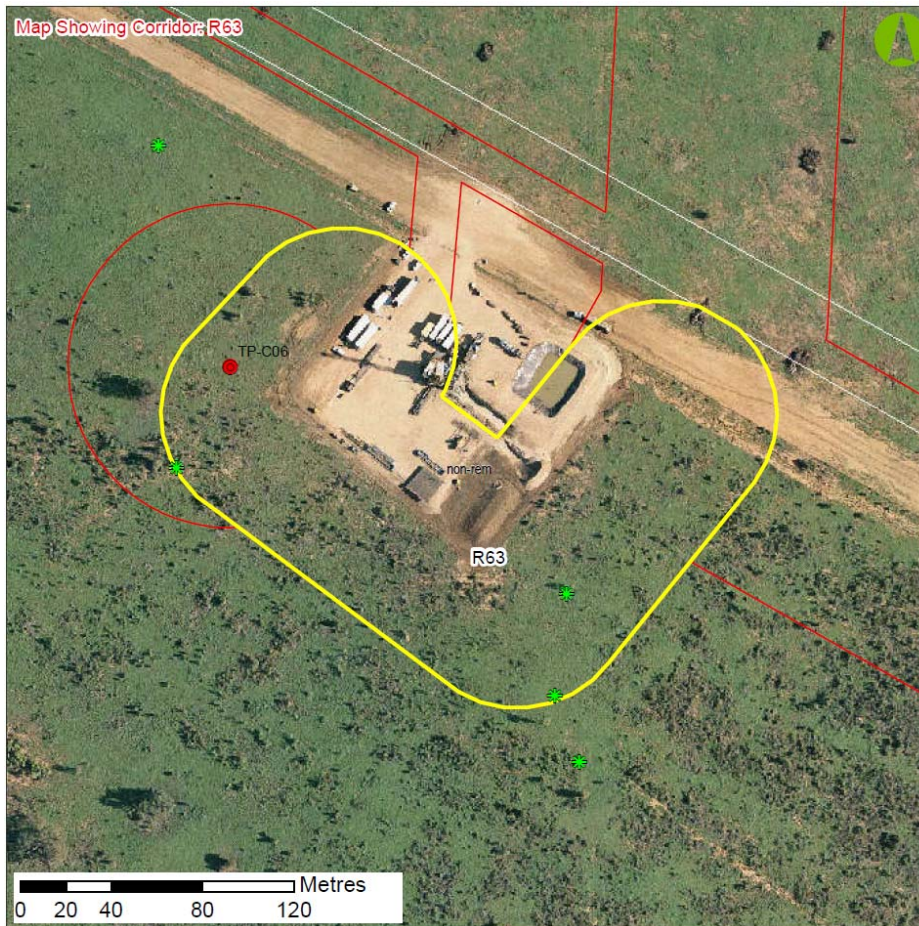
The proposed area of disturbance is currently mapped as non remnant on the DERM RE mapping. The area does not occur within any areas identified as ESA's and the nearest ESA is located more than 2.7 km to the west of the proposed corridor.

No watercourses are mapped within the proposed corridor footprint, with the nearest watercourse located approximately 400 m to the east.

Figure 3-9 Aerial photograph of proposed corridor R63 * - denotes the location of Type A species
