**Fairview Ecological
Assessment Report – Lots 1
AB73, 1 AB247, 2 AB247 & 46
FTY1813
Santos Ltd**

Report ref:
221708-001
15 June 2011
Revision 0

Santos Document No: 0020-GLNG-4-1.3-0052 rev0

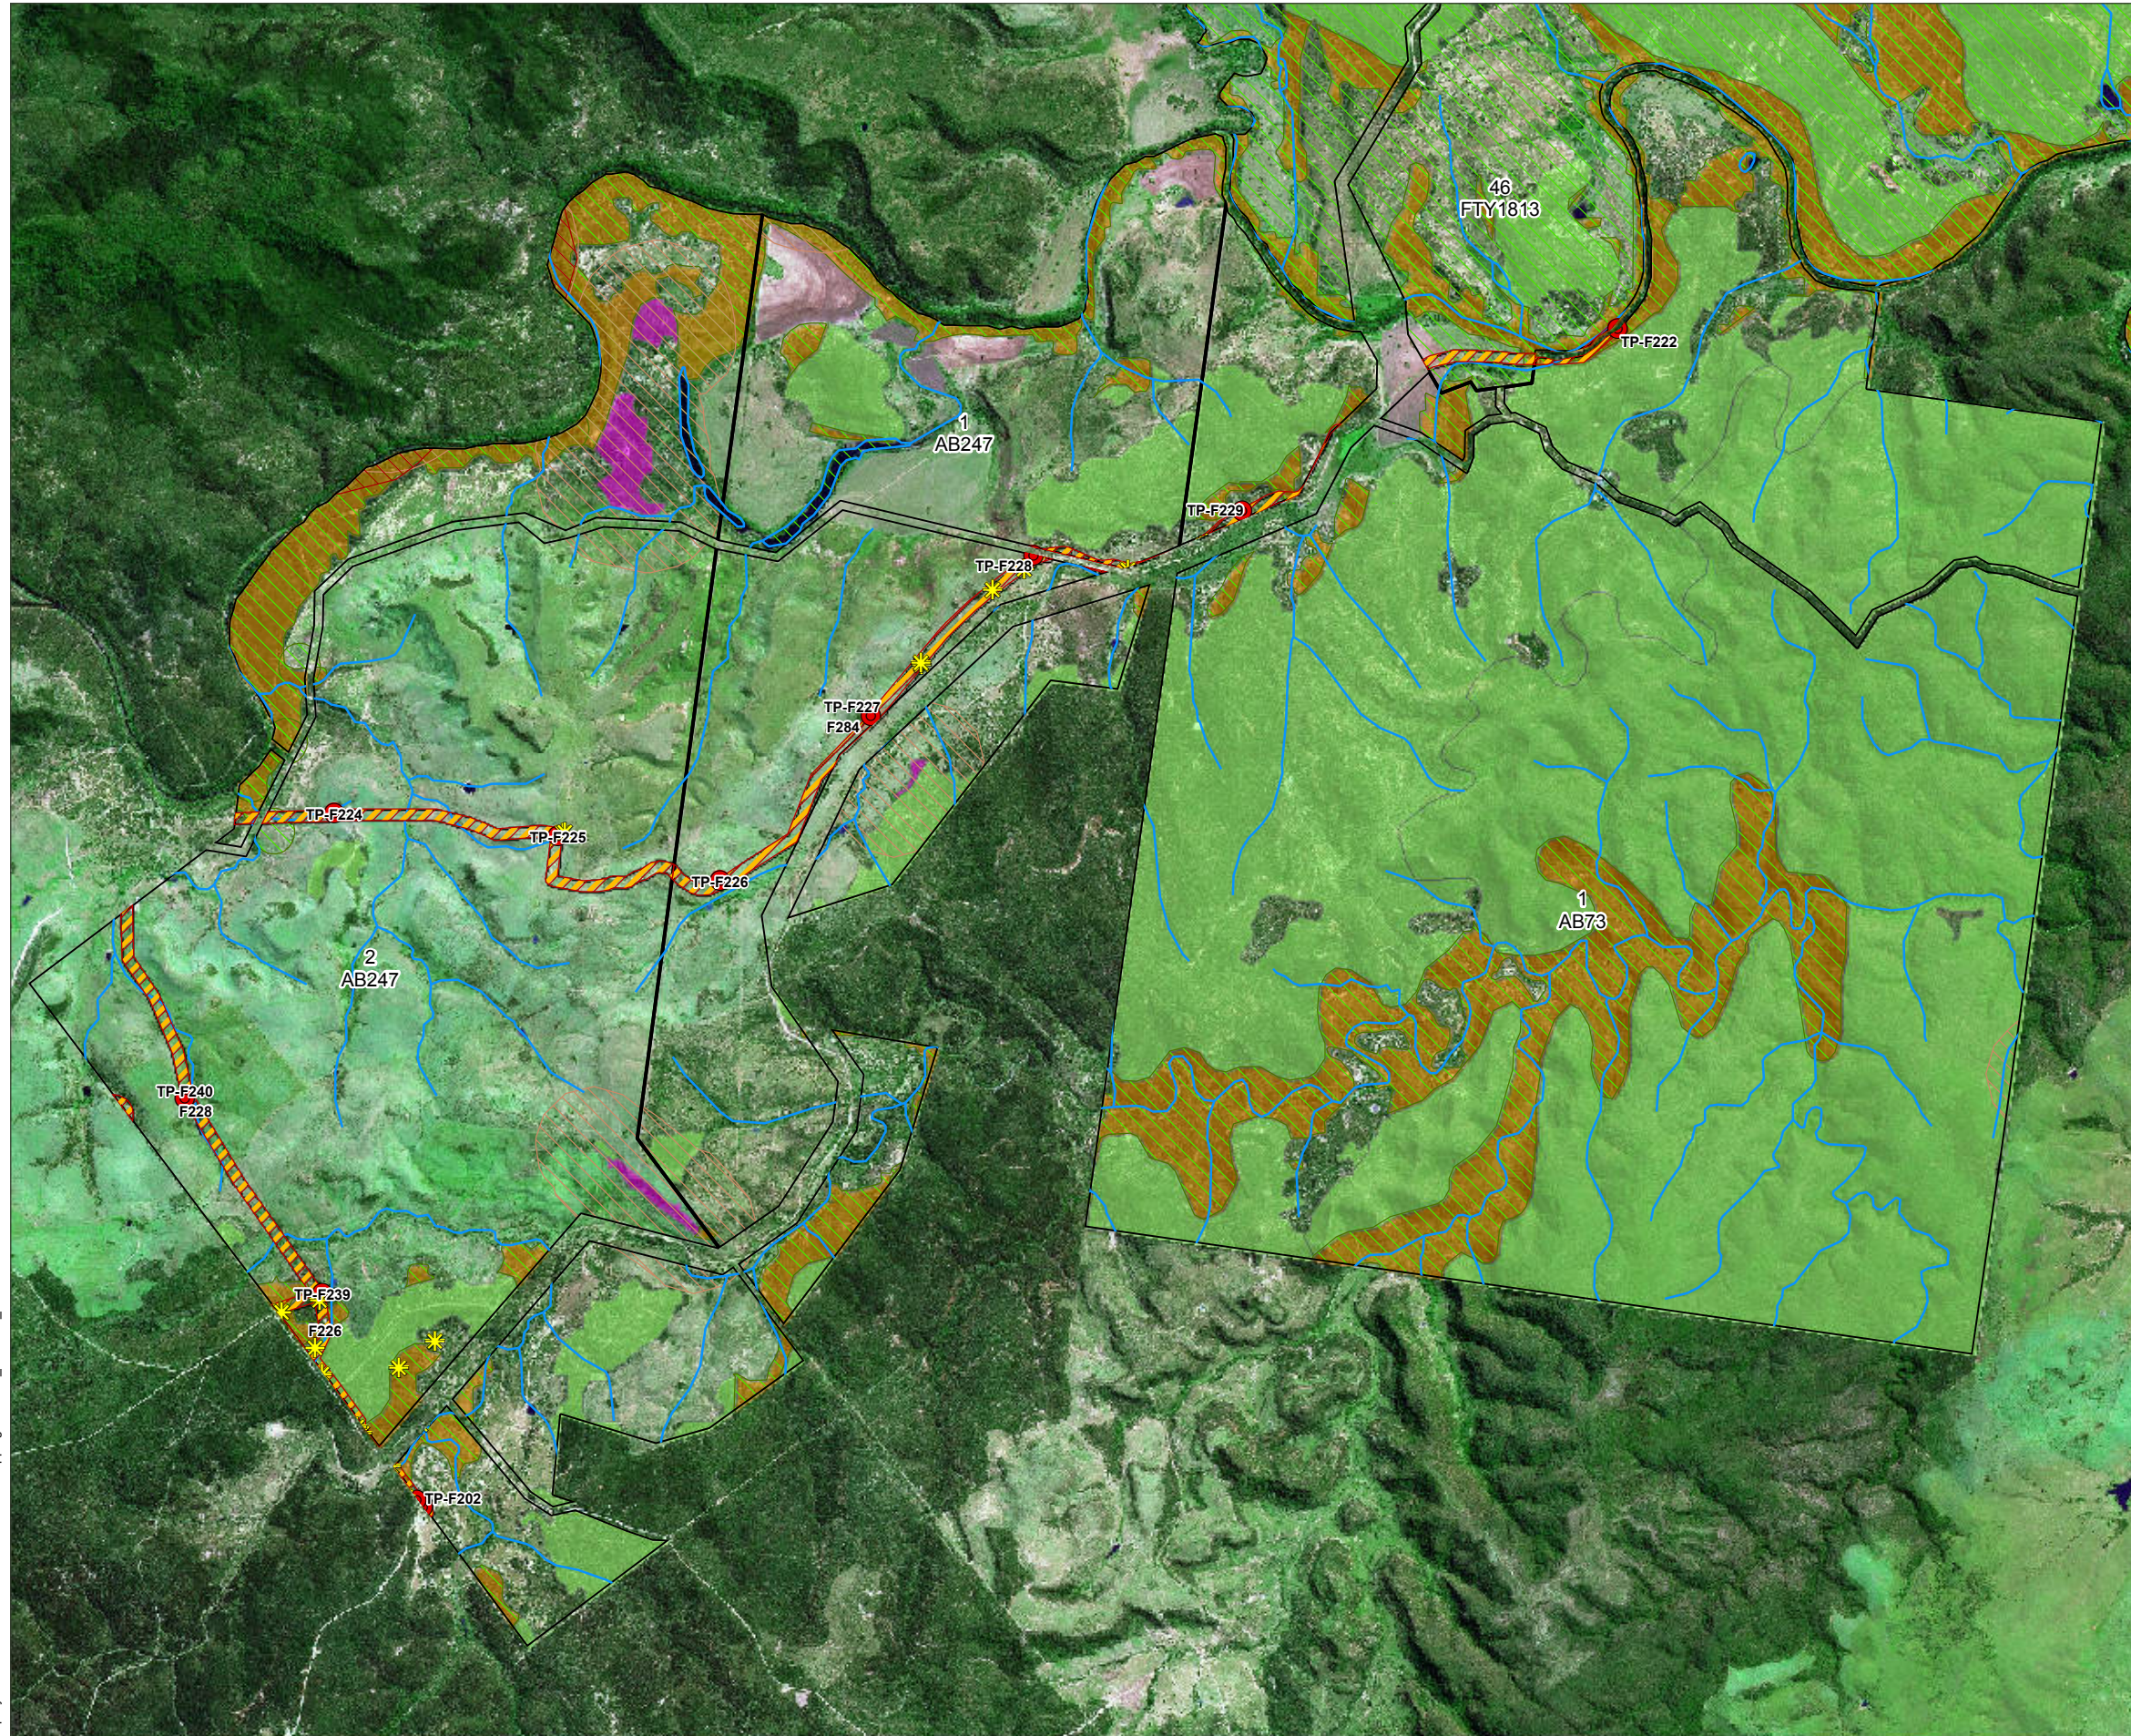
This report is specific to the proposed development areas listed below and shown in Figure 1-1 and Figure 1-2:

- Pipeline corridors F226, F227, F228 and F284 and 6339-RM-59
- Geotechnical survey locations situated within the above corridors and shown in Figure 1-1

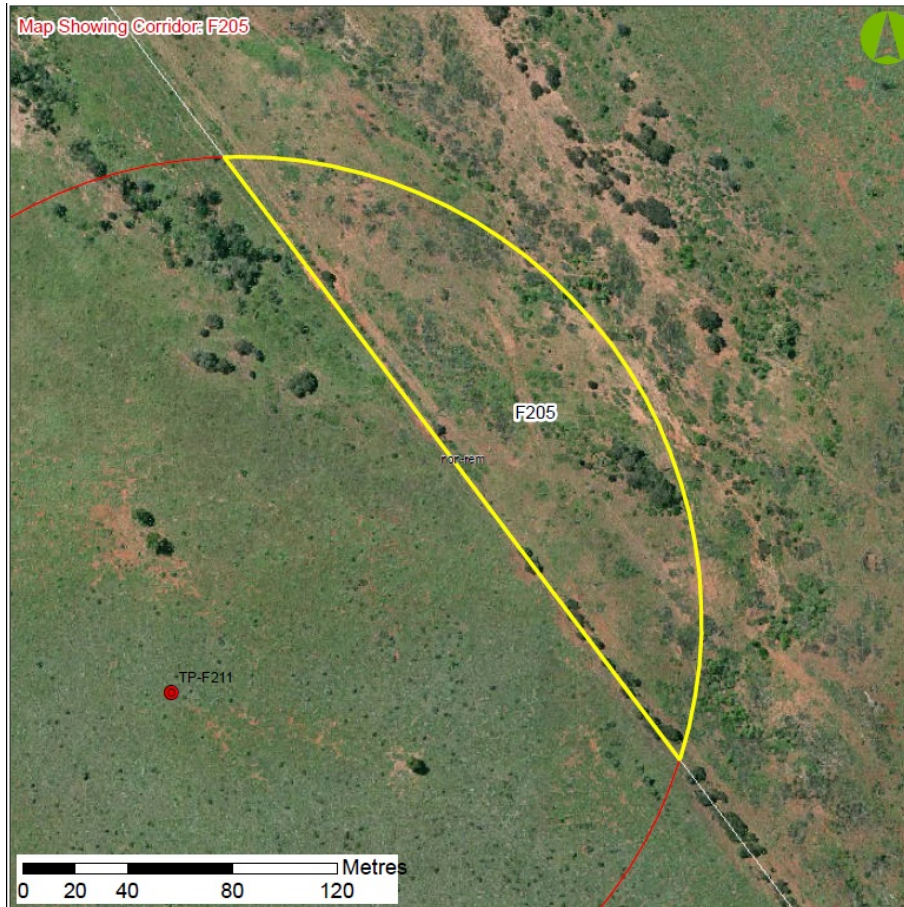
Figure 3-1 Aerial photograph and associated RE mapping of proposed corridor F205

Only a small section of the corridor F205 occurs within Lot 2 AB247 (Figure 3-1). This corridor is not discussed in this report as it was covered in the Lot 8 AB200 report, submitted 17 June 2011.

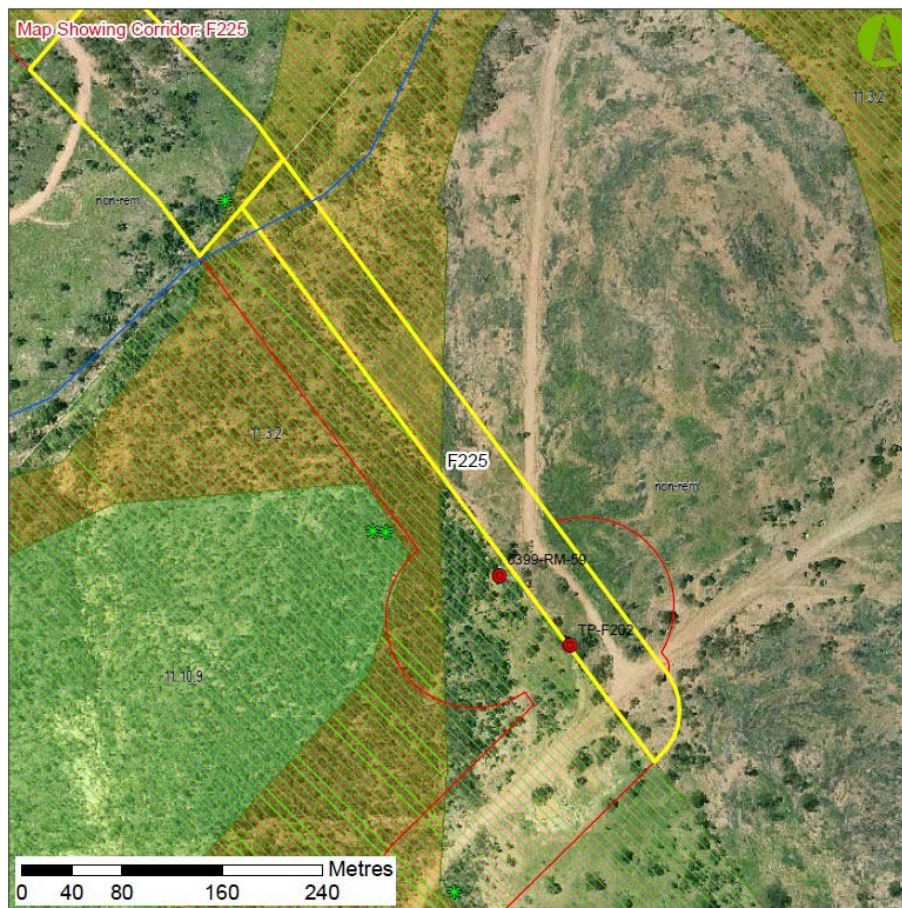
Figure 3-2 Aerial photograph and associated RE mapping of proposed corridor F225

The proposed disturbance area within corridor F225 occurs across areas mapped at non-remnant and RE 11.3.2 which is 'of concern' vegetation. These areas are therefore classed as a 'Category C' Environmentally Sensitive Area (ESA). The non-remnant mapping was confirmed while the 11.3.2 mapping was not confirmed and is discussed further below.

There is an access track at the southern section of F225 and the corridor intersects a watercourse (classified by DERM as stream order 2). Figure 3-2 shows the proposed corridor F225.

The vegetation that occurs within corridors F225 is a White Cypress Pine Woodland. The dominant canopy species are *Callitris glaucophylla* (White Cypress Pine) with some *Eucalyptus melanophloia* (Silver Leaved Ironbark) and *Eucalyptus populnea* (Poplar Box). The mid-stratum and shrub layers was sparse due to dense stands of *C. glaucophylla*, the predominant species were Acacias (*Acacia complanata*, *Acacia excelsa* and *Acacia leiocalyx*). The groundcover consisted of a dense native grass layer with a range of native herbs also present. Weed species were more prominent in the non-remnant areas, such as *Opuntia stricta* (Prickly Pear) and *Pennisetum ciliare* (Buffel).

The RE 11.3.2 is described as *Eucalyptus populnea* woodland on alluvial plains, and was not present in the area mapped as *E. populnea* was not the dominant canopy species and the geology was sandstone ranges not alluvial plains. This vegetation described above occurs across all corridors and geo-tech sites and is consistent with RE mapping 11.10.9. It is suggested that the area within corridor F225 that is mapped as RE 11.3.2 should be a continuation of 11.10.9.

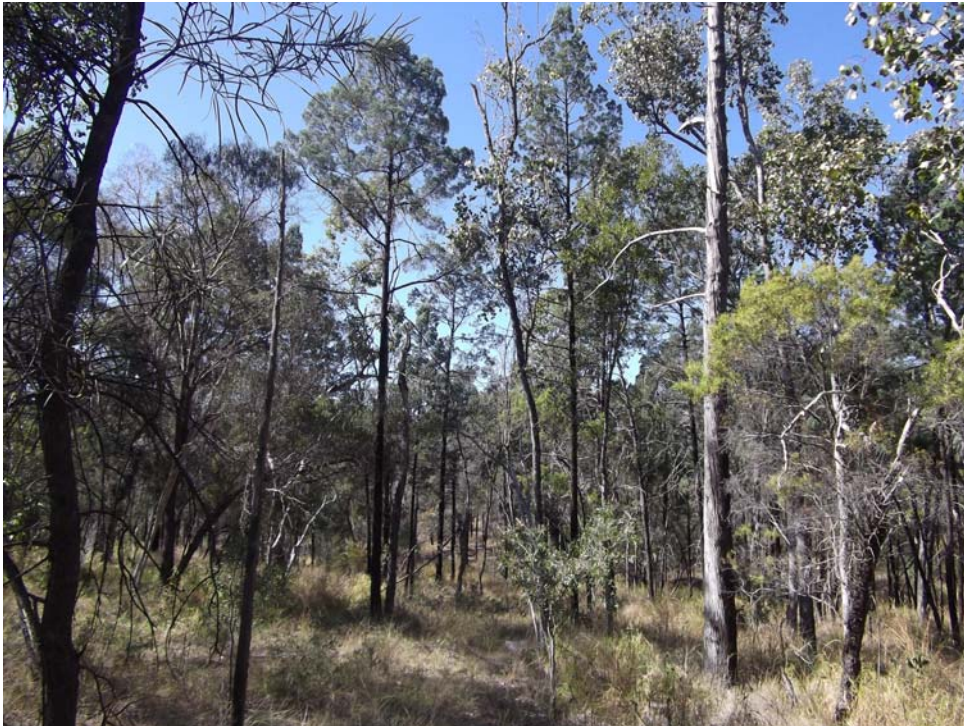
The proposed disturbance area is densely vegetated with a White Cypress Woodland / Eucalypt forest. The canopy is dominated by *Callitris glaucophylla* (White Cypress) with *Eucalyptus populnea*

(Poplar Box) and *Eucalyptus melanophloia* (Silver Leaved Ironbark) as the dominant eucalypt species. The mid-storey is sparsely vegetated with woody shrubs including *Eremophila mitchellii* (False Sandalwood) and *Acacia leiocalyx* (Black Wattle). *Acacia excelsa* (Iron Wood) is the dominant shrub species at the southern end of the corridor. Ground cover is dominated by native grasses and herbs such as *Themeda triandra* (Kangaroo Grass), *Cymbopogon refractus* (Barbed Wire Grass) and *Cheilanthes sieberi* (Mulga Fern). Weed species such as *Pennisetum ciliare* (Buffel Grass) and *Opuntia tomentosa* (Velvety Tree Pear). Plate 3-1 below shows an example of typical vegetation found within the corridor.

Plate 3-1 Site photograph of corridor F226 showing typical vegetation type (White Cypress / Eucalypt woodland)

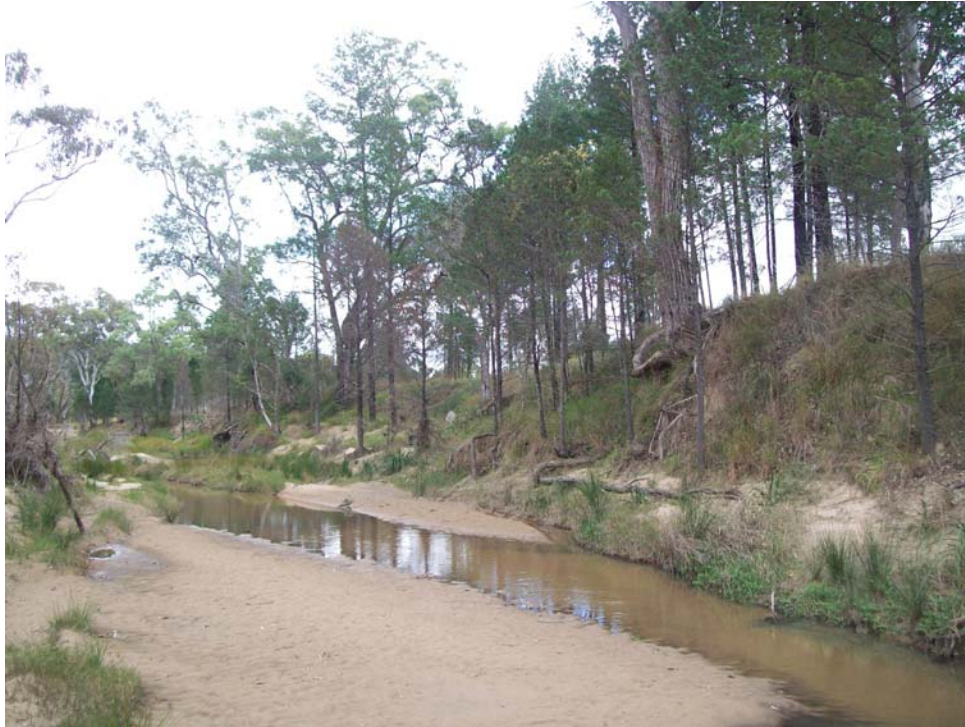
Floristic variation within the site occurred due to changes in topography. A creek line was identified within which, *Angophora floribunda* (Rough Barked Apple) was the dominant overstorey species. *Eleocharis* (Spike Rush) and *Juncus usitatus* (Juncus) also occurred within the creek (Plate 3-2).

Plate 3-2 Site photograph of corridor F226 showing creek line with *Angophora floribunda*

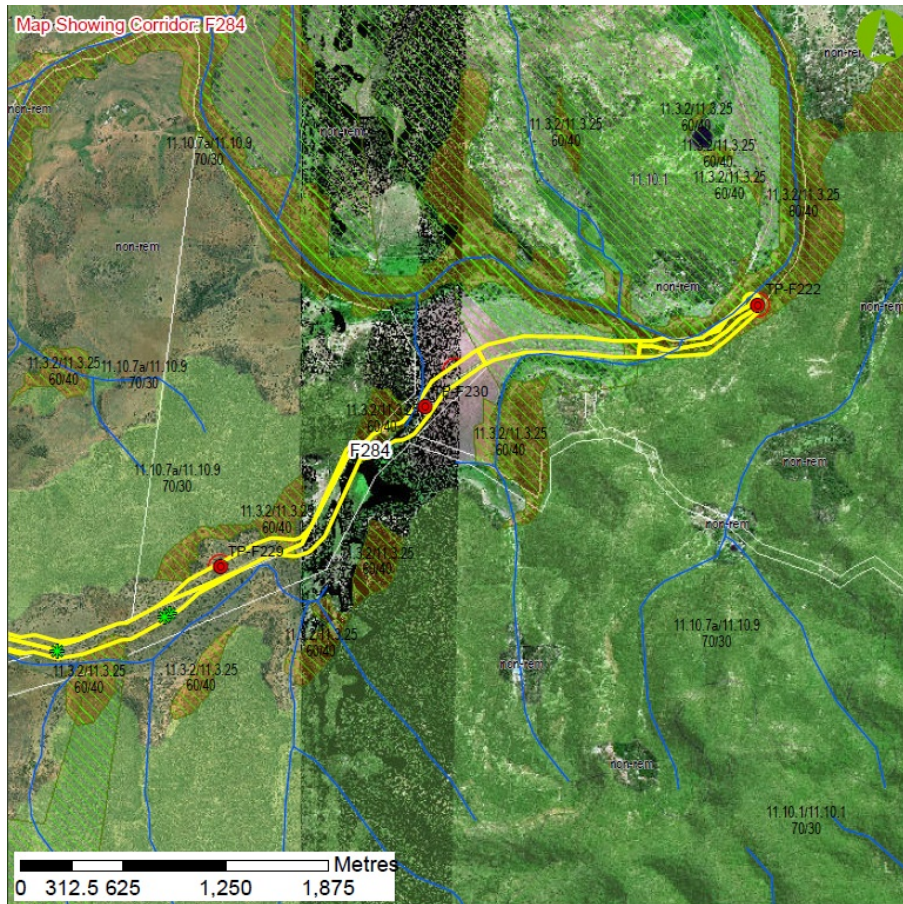
Remnant vegetation exists within the corridor, particularly at the eastern end along the Hudson River. RE mapping classifies the existing vegetation as RE11.10.7a/11.10.9, RE11.3.2/11.3.25 and non-remnant which are listed as 'no concern at present', 'of concern – dominant' and 'of no concern' respectively. Surveys found that the RE vegetation mapping was correct.

RE 11.3.2/11.3.25 (*Eucalyptus populnea* woodland) is an 'of concern' regional ecosystem which falls within the proposed corridor in several places. This means that these areas are classified as 'Category C' Environmentally Sensitive Areas (ESAs).

The Hutton River (stream order 6) intersects the proposed corridor at the eastern end of the corridor. Several small gullies that in times of heavy rain potentially may flow also intersect the proposed corridor in several places. These were dry at the time of surveys.

Cultivation is present within the eastern end of the proposed corridor. Figures Figure 3-9 to Figure 3-19 below illustrates the proposed corridor.

Figure 3-9 Aerial photograph and associated RE mapping of proposed corridor 284

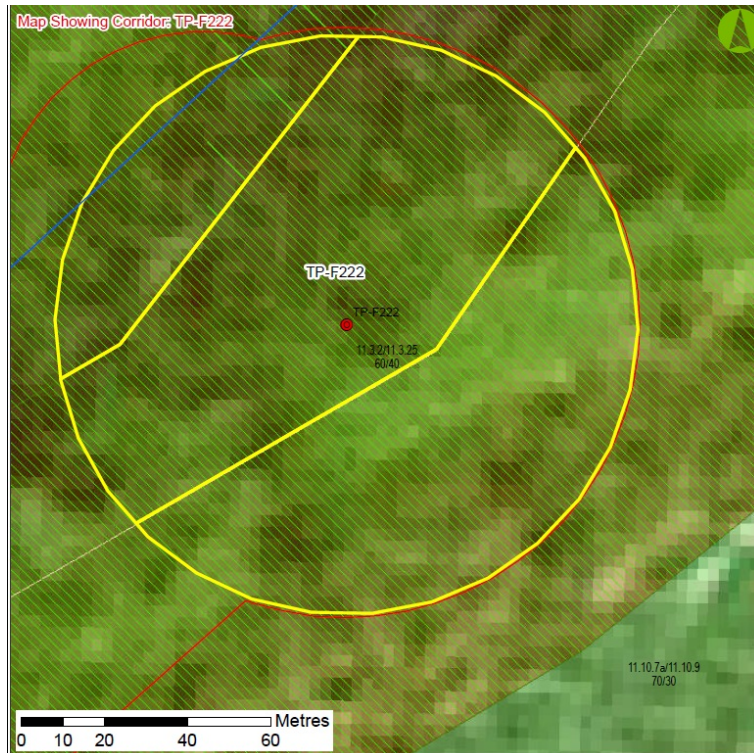
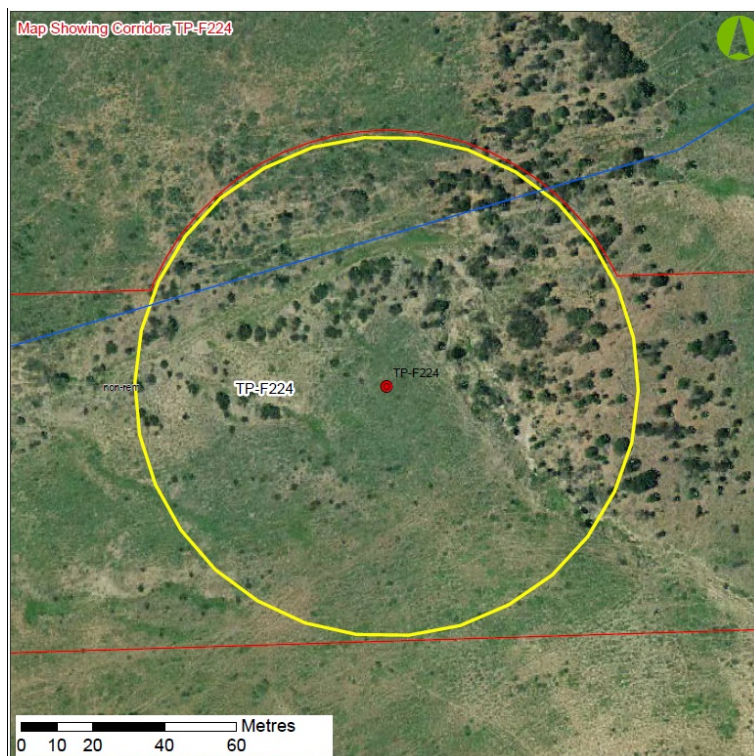
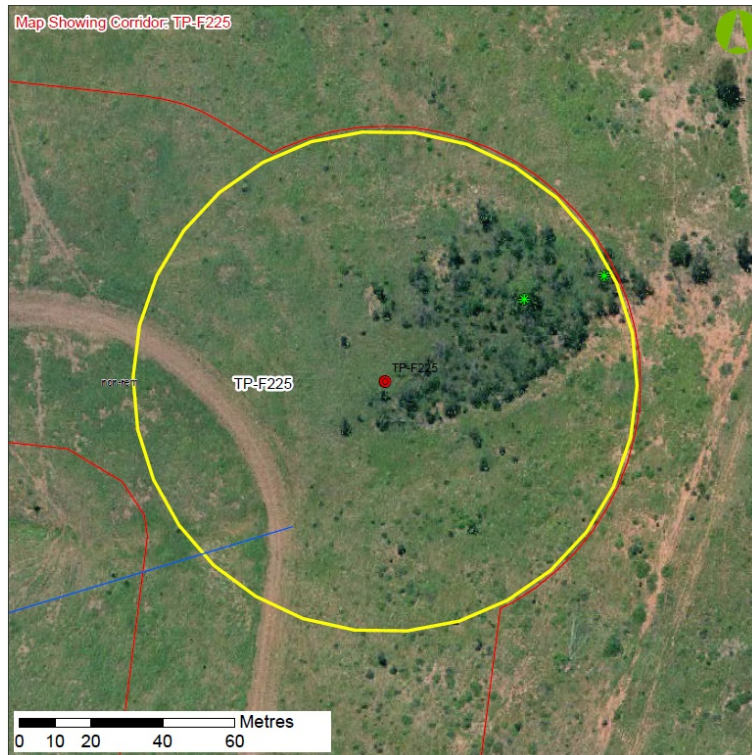
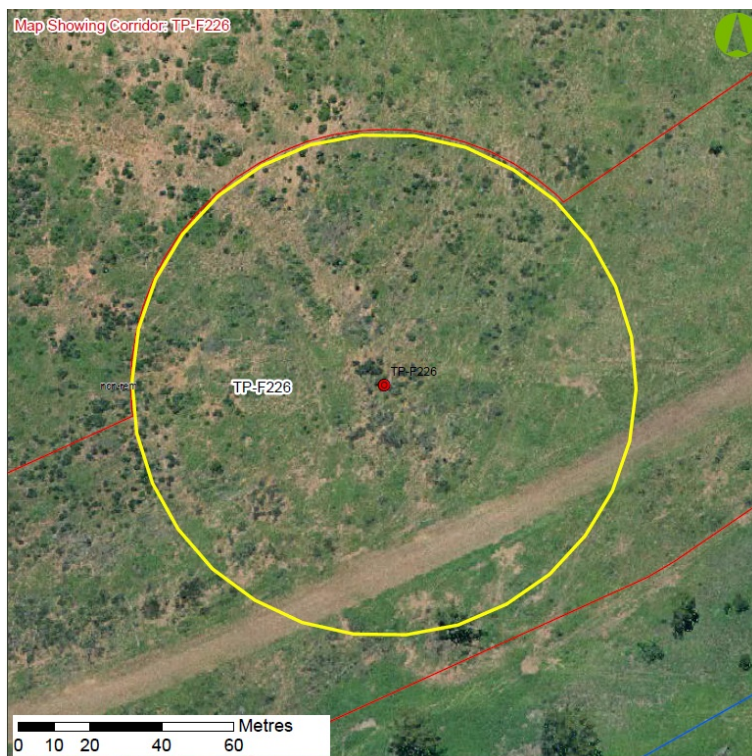
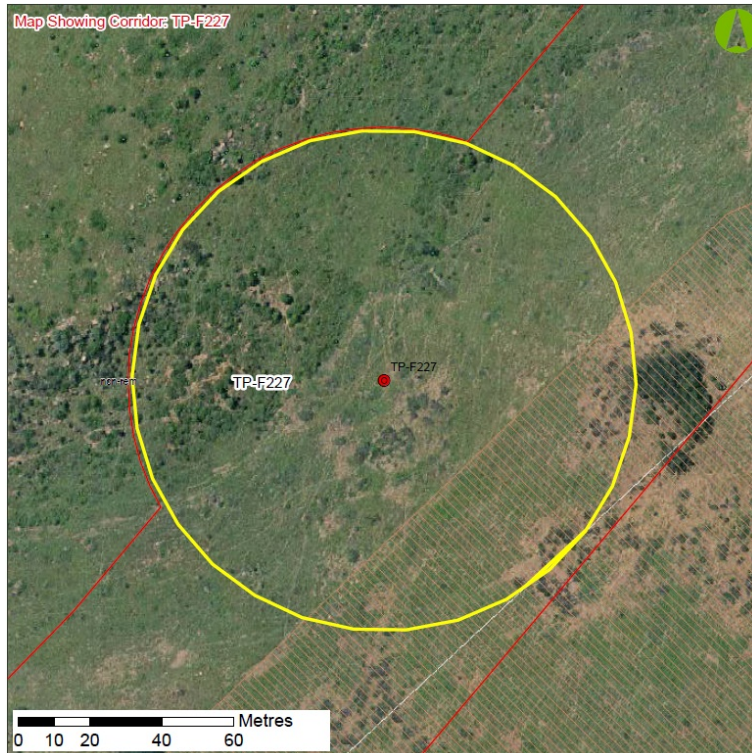
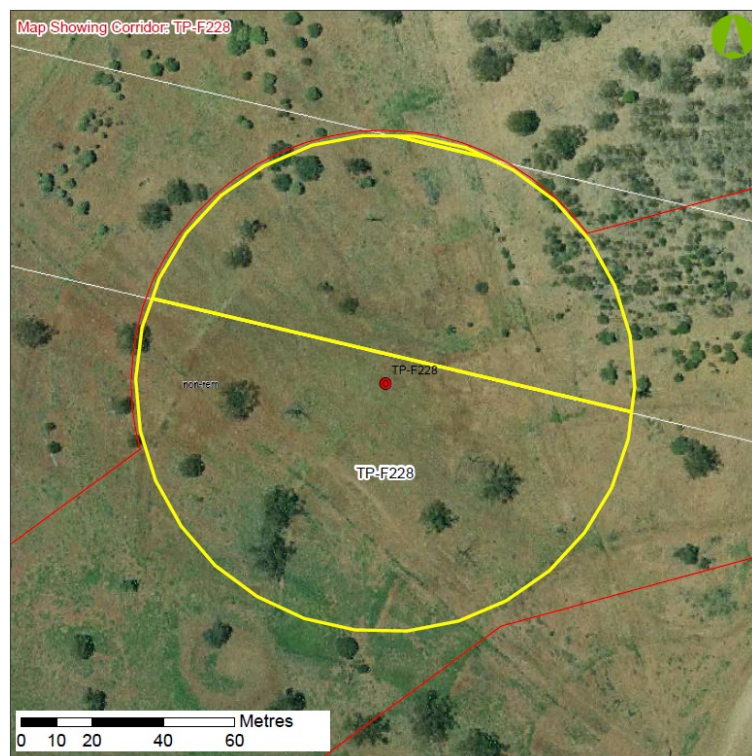
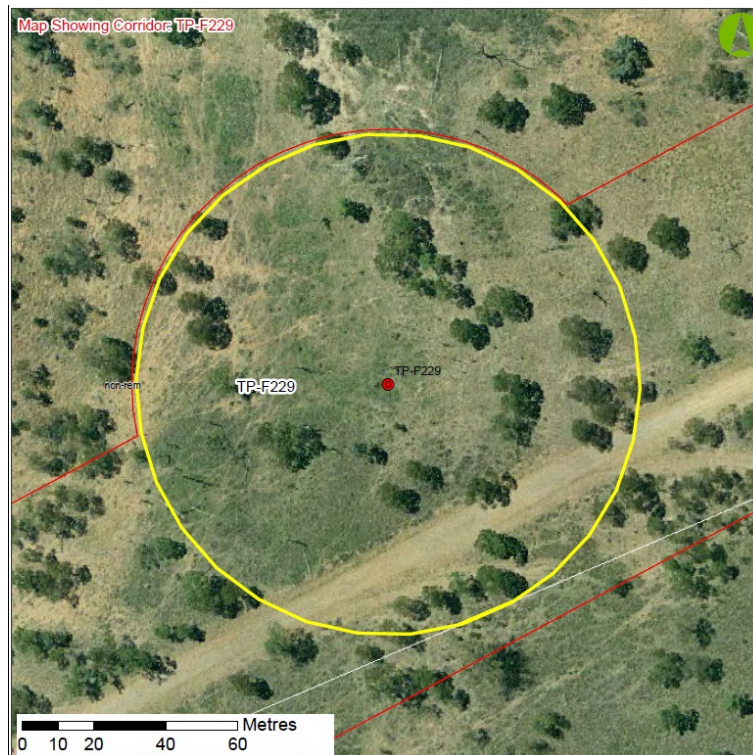
Figure 3-13 Aerial photograph and associated RE mapping of proposed geo-tech site TP-F222

Figure 3-14 Aerial photograph and associated RE mapping of proposed geo-tech site TP-F224

Figure 3-15 Aerial photograph and associated RE mapping of proposed geo-tech site TP-F225

Figure 3-16 Aerial photograph and associated RE mapping of proposed geo-tech site TP-F226

Figure 3-17 Aerial photograph and associated RE mapping of proposed geo-tech site TP-F227

Figure 3-18 Aerial photograph and associated RE mapping of proposed geo-tech site TP-F228

Figure 3-19 Aerial photograph and associated RE mapping of proposed geo-tech site TP-F222
