**Santos GLNG Project**  
**Lot 20 FTY1805**  
**Phase 2 Ecological Assessment Report**

December 2013

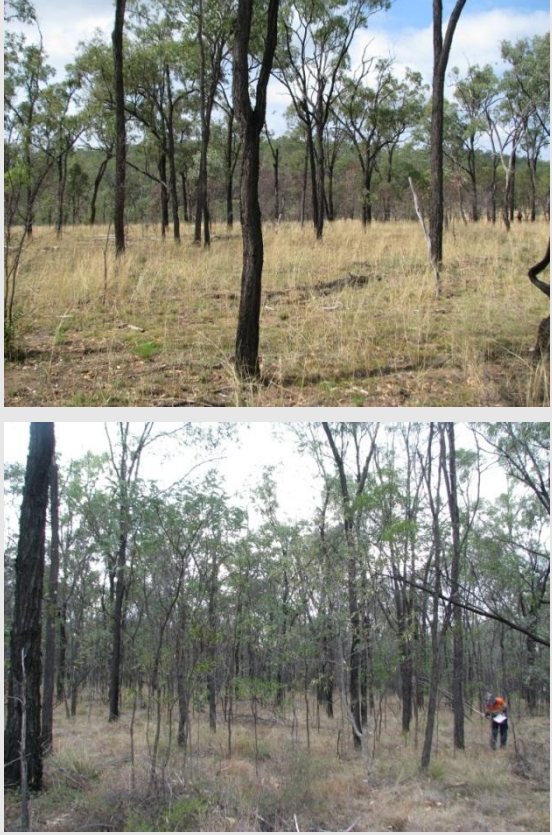
Polygon	Mapped RE	Observed RE	Community Description	Representative Photo
1	11.3.39/11.3.2	11.10.1c/11.10.7	<p>This polygon is located in the northern extent of Lot 20 on FTY1805.</p> <p><b>Land zone:</b> Occurs on landforms derived from underlying or outcropping sedimentary rock, including Jurassic cross-bedded quartzose sandstone, sub-labile and labile sandstone, siltstone and mudstone, consistent with land zones 9 or 10. Landforms are derived from the Precipice Sandstone and Evergreen Sandstone formations.</p> <p><b>Tree layers:</b> Field surveys found this area to contain a mixed polygon of open forest (10–17 m) dominated by <i>Eucalyptus fibrosa subsp. nubila</i> and <i>E. crebra</i>. Other associated tree species observed includes <i>E. melanophloia</i>, <i>C. trachyphloia</i> and <i>Acacia shirleyi</i>.</p> <p><b>Shrub Layers:</b> The shrub layer was frequently dominated by <i>Acacia leiocalyx</i> and <i>Alphitonia excelsa</i> with other associated species including <i>Acacia longispicata</i>, <i>Petalostigma pubescens</i> and <i>Carissa ovata</i>.</p> <p><b>Ground Layer:</b> The groundcover consisted primarily of native grasses (sparse to moderately dense) including <i>Aristida caput-medusae</i>, <i>Themeda triandra</i> and <i>Enneapogon</i> spp..</p>

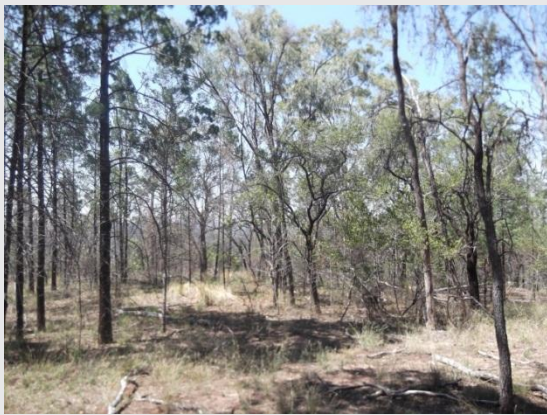
Polygon	Mapped RE	Observed RE	Community Description	Representative Photo
3	11.3.39/11.3.2	11.10.1	<p>This polygon is located in the northern extent of Lot 20 on FTY1805.</p> <p><b>Land zone:</b> Occurs on landforms derived from underlying or outcropping sedimentary rock, including Jurassic sub-labile and labile sandstone, mudstone and minor shale and coal, consistent with land zones 9 or 10. Landforms are derived from the Evergreen Sandstone formations.</p> <p><b>Tree Layers:</b> Field surveys found this area to contain open forest (12–16 m) dominated by <i>Corymbia citriodora</i> and <i>Eucalyptus fibrosa subsp. nubila</i>. Other associated tree species observed includes <i>C. tessellaris</i> and <i>Callitris glaucophylla</i>.</p> <p><b>Shrub Layers:</b> The shrub layer was dominated by <i>Petalostigma pubescens</i> with associated species consisting of <i>Alphitonia excelsa</i>, <i>Geijera parviflora</i>, <i>Psydrax odorata</i> and <i>Croton insularis</i>.</p> <p><b>Ground Layer:</b> The groundcover consisted primarily of grass species (moderately dense) including <i>Aristida caput-medusae</i>, <i>Ancistrachne uncinulata</i> and <i>Cenchrus ciliaris</i>.</p>

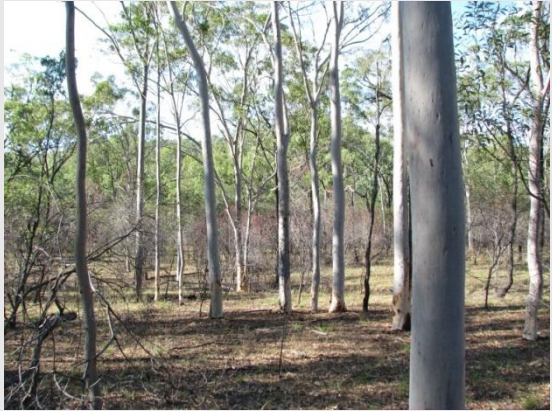
Polygon	Mapped RE	Observed RE	Community Description	Representative Photo
4	11.3.39/11.3.2	11.10.1	<p>This polygon is located in the northern extent of Lot 20 on FTY1805.</p> <p><b>Land zone:</b> Occurs on landforms derived from underlying or outcropping sedimentary rock, including Jurassic sub-labile and labile sandstone, mudstone and minor shale and coal, consistent with land zones 9 or 10. Landforms are derived from the Evergreen Sandstone formation.</p> <p><b>Tree Layers:</b> Field surveys found this area to contain open forest (11–17 m) dominated by <i>Corymbia citriodora</i> and <i>Eucalyptus crebra</i>. Other associated tree species observed includes <i>E. fibrosa</i> subsp. <i>nubila</i>, <i>E. melanophloia</i> and <i>E. populnea</i>.</p> <p><b>Shrub Layers:</b> The shrub layer was dominated by <i>Acacia leiocalyx</i> with associated species consisting of <i>Petalostigma pubescens</i>, <i>Alphitonia excelsa</i>, <i>Callitris glaucophylla</i>, <i>Capparis mitchellii</i> and <i>Carissa ovata</i>.</p> <p><b>Ground Layer:</b> The groundcover consisted primarily of grass species (moderately dense) including <i>Aristida calycina</i>, <i>Enneapogon nigricans</i> and <i>A. caput-medusae</i>.</p>

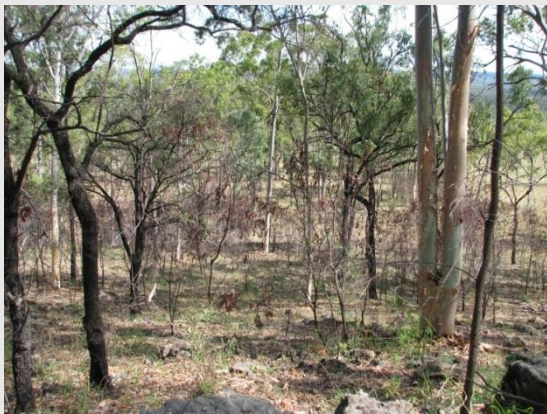
Polygon	Mapped RE	Observed RE	Community Description	Representative Photo
5	11.3.39/11.3.2	11.10.1	<p>This polygon is located in the north-eastern extent of Lot 20 on FTY1805.</p> <p><b>Land zone:</b> Occurs on landforms derived from underlying or outcropping sedimentary rock, including Jurassic cross-bedded quartzose sandstone, sub-labile lithic sandstone and siltstone, consistent with land zones 9 or 10. Landforms are derived from the Precipice Sandstone formation.</p> <p><b>Tree Layers:</b> Field surveys found this area to contain open forest (14–17 m) dominated by <i>Corymbia citriodora</i> with subdominant and associated <i>Eucalyptus crebra</i> and <i>E. fibrosa</i>.</p> <p><b>Shrub Layers:</b> The shrub layer was dominated by <i>Acacia leiocalyx</i> with associated species consisting of <i>Acacia shirleyi</i>, <i>Alphitonia excelsa</i>, <i>Callitris glaucophylla</i>, <i>Acacia longispicata</i> and <i>Petalostigma pubescens</i>.</p> <p><b>Ground Layer:</b> The groundcover consisted primarily of grass species (moderately dense) including <i>Aristida calycina</i>, <i>Themeda triandra</i> and <i>A. caput-medusae</i>.</p>

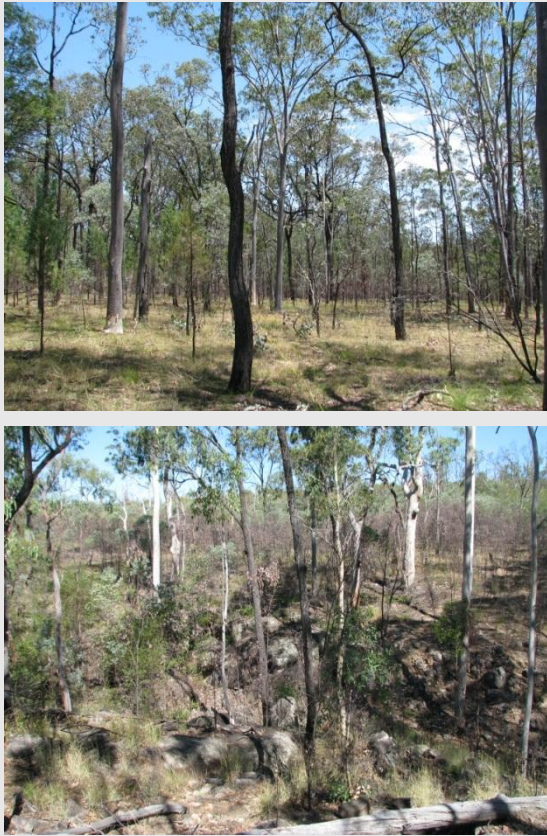
Polygon	Mapped RE	Observed RE	Community Description	Representative Photo
6	11.3.2/11.3.25	11.10.1/11.10.7	<p>This polygon is located in the eastern extent of Lot 20 on FTY1805.</p> <p><b>Land zone:</b> Occurs on landforms derived from underlying or outcropping sedimentary rock, including Jurassic cross-bedded quartzose sandstone, sub-labile lithic sandstone and siltstone, consistent with land zones 9 or 10. Landforms are derived from the Precipice Sandstone formation.</p> <p><b>Tree Layers:</b> Field surveys found this area to contain a mixed polygon of open forest (11–17 m) dominated by <i>Eucalyptus melanophloia</i> and <i>Corymbia citriodora</i>. <i>E. crebra</i> and found to be dominant at times. Other associated tree species observed includes <i>E. fibrosa subsp. nubila</i>, <i>E. crebra</i>, <i>Angophora leiocarpa</i> and <i>Callitris glaucophylla</i>.</p> <p><b>Shrub Layers:</b> The shrub layer was dominated by <i>Acacia leiocalyx</i> and <i>Acacia longispicata</i> with associated species consisting of <i>Alphitonia excelsa</i>, <i>Callitris glaucophylla</i>, <i>Terminalia oblongata</i> <i>Acacia longispicata</i> and <i>Dodonaea triangularis</i>.</p> <p><b>Ground Layer:</b> The groundcover consisted primarily of grass species (moderately dense) including <i>Arundinella nepalensis</i>, <i>Aristida caput-medusae</i>, <i>Themeda triandra</i> and <i>Ancistrachne uncinulata</i>.</p>

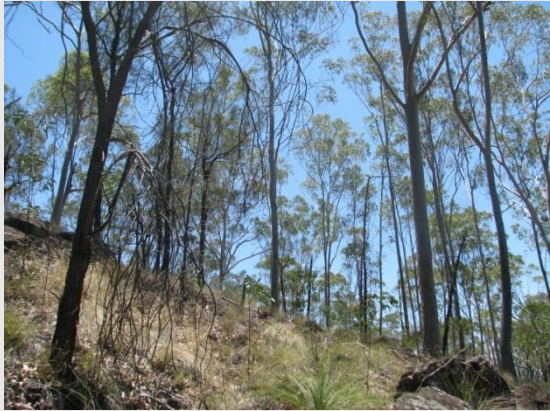
Polygon	Mapped RE	Observed RE	Community Description	Representative Photo
7	11.9.4a	11.10.1	<p>This polygon is located in the eastern extent of Lot 20 on FTY1805.</p> <p><b>Land zone:</b> Occurs on landforms derived from underlying or outcropping sedimentary rock, including Jurassic quartzose sandstone, sub-labile and labile sandstone, mudstone and siltstone, consistent with land zones 9 or 10. Landforms are derived from the Evergreen Sandstone formation and Boxvale Sandstone Member.</p> <p><b>Tree Layers:</b> Field surveys found this area to contain open forest (10–17 m) dominated by <i>Corymbia citriodora</i>. Other associated tree species observed includes <i>E. decorticans</i> and <i>Callitris glaucophylla</i>.</p> <p><b>Shrub Layers:</b> The shrub layer was dominated by <i>Acacia bancroftiorum</i> with associated species consisting of <i>Acacia macradenia</i>, <i>Callitris glaucophylla</i>, <i>A. longispicata</i>, <i>A. leiocalyx</i> and <i>Dodonaea triangularis</i>.</p> <p><b>Ground Layer:</b> The groundcover consisted primarily of grass species (moderately dense) including <i>Cymbopogon bombycinus</i>, <i>Themeda triandra</i> and <i>Ancistrachne uncinulata</i>.</p>

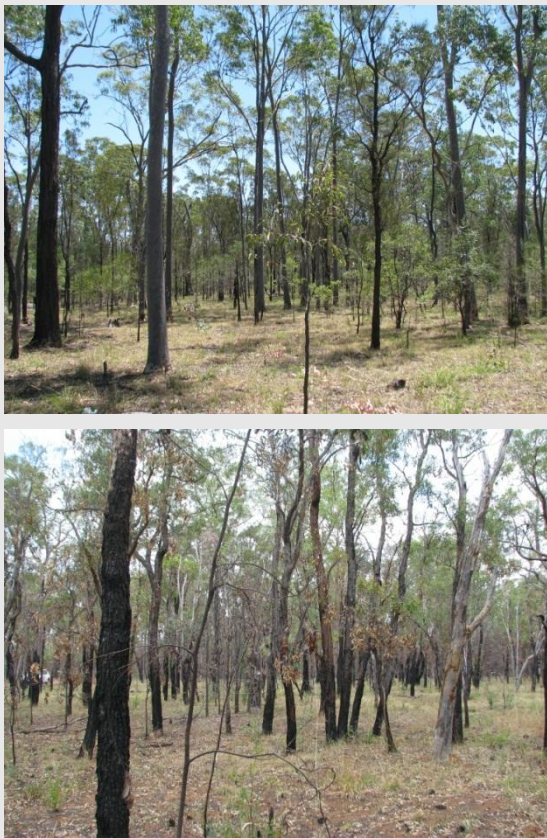
Polygon	Mapped RE	Observed RE	Community Description	Representative Photo
8	11.10.1/11.10.13 a	11.10.1/11.10.4	<p>This polygon is located in the central and western extent of Lot 20 on FTY1805.</p> <p><b>Land zone:</b> Occurs on landforms derived from underlying or outcropping sedimentary rock, including Jurassic quartzose sandstone, sub-labile and labile sandstone, mudstone and siltstone, consistent with land zones 9 or 10. Landforms are derived from the Evergreen formation and Boxvale Sandstone Member.</p> <p><b>Tree Layers:</b> Field surveys found this area to contain a mixed polygon of open forest (9–18 m) dominated by <i>Corymbia citriodora</i>, <i>Eucalyptus fibrosa</i> subsp. <i>nubila</i> and <i>E. tenuipes</i>. Other associated tree species observed includes <i>E. crebra</i>, <i>C. trachyphloia</i>, <i>Lysicarpus angustifolius</i>, <i>Angophora leiocarpa</i> and <i>Callitris glaucophylla</i>.</p> <p><b>Shrub Layers:</b> The shrub layer was dominated by <i>Acacia leiocalyx</i>, <i>A. longispicata</i>, <i>Petalostigma pubescens</i> with associated species consisting of <i>Alphitonia pubescens</i>, <i>Geijera parviflora</i>, <i>Psyrax odorata</i> and <i>Callitris glaucophylla</i>.</p> <p><b>Ground Layer:</b> The groundcover consisted primarily of grass species (sparse to moderately dense) including <i>Cymbopogon bombycinus</i>, <i>Themeda triandra</i>, <i>Arundinella nepalensis</i>, <i>Panicum effusum</i>, <i>Aristida caput-medusae</i> and <i>Enneapogon spp.</i>.</p>

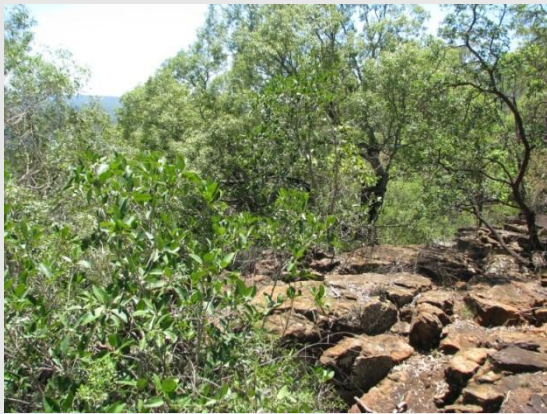
Polygon	Mapped RE	Observed RE	Community Description	Representative Photo
9	11.10.1/11.10.1	11.9.4a	<p>This polygon is located in the north-eastern extent of Lot 20 on FTY1805.</p> <p><b>Land zone:</b> Occurs on landforms derived from underlying or outcropping sedimentary rock, including Jurassic quartzose sandstone, sub-labile and labile sandstone, mudstone, consistent with land zones 9 or 10. Landforms are derived from the Evergreen formation and Boxvale Sandstone Member.</p> <p><b>Tree Layers:</b> Field surveys found this area to contain semi evergreen vine thicket with an emergent layer (11–13 m) of <i>Brachychiton</i> spp. and a tree layer dominated by <i>Diospyros humilis</i>. Other associated tree species observed includes <i>Flindersia australis</i>, <i>Atalaya hemiglauca</i> and <i>Brachychiton</i> spp.</p> <p><b>Shrub Layers:</b> The shrub layer was dominated by <i>Geijera parviflora</i>, <i>Ficus rubiginosa</i> and <i>Carissa ovata</i> with associated species consisting of <i>Cupaniopsis anacardioides</i>, <i>Denhamia oleaster</i>, <i>Psyrdrax odorata</i> and <i>Turraea pubescens</i>.</p> <p><b>Ground Layer:</b> The groundcover consisted primarily of grass species (sparse to moderately dense) including <i>Ancistrachne uncinulata</i>, <i>Themeda avenacea</i> and <i>Aristida caput-medusae</i>.</p>

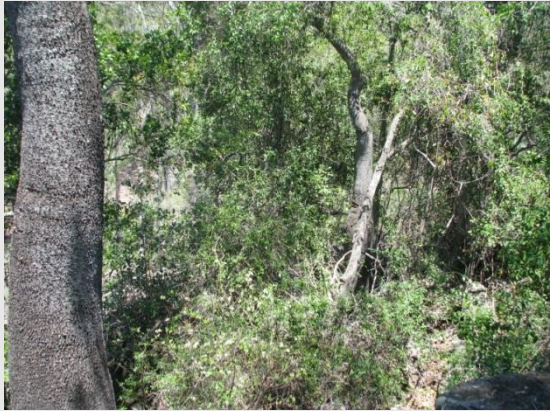
Polygon	Mapped RE	Observed RE	Community Description	Representative Photo
10	11.10.1/11.10.1	11.9.4a	<p>This polygon is located in the north-eastern extent of Lot 20 on FTY1805.</p> <p><b>Land zone:</b> Occurs on landforms derived from underlying or outcropping sedimentary rock, including Jurassic quartzose sandstone, sub-labile and labile sandstone, mudstone, consistent with land zones 9 or 10. Landforms are derived from the Evergreen formation and Boxvale Sandstone Member.</p> <p><b>Tree Layers:</b> Field surveys found this area to contain semi evergreen vine thicket with an emergent layer (12–14 m) of <i>Brachychiton</i> spp. and a tree layer dominated by <i>Diospyros humilis</i> and <i>Brachychiton populneus</i>. Other associated tree species observed includes <i>Brachychiton rupestris</i>, and <i>Geijera parviflora</i>.</p> <p><b>Shrub Layers:</b> The shrub layer was dominated by <i>Ficus rubiginosa</i> and <i>Carissa ovata</i> with associated species consisting of <i>Cupaniopsis anacardioides</i>, <i>Acalypha capillipes</i>, <i>Flindersia australis</i> and <i>Croton insularis</i>.</p> <p><b>Ground Layer:</b> The groundcover was dominated primarily by <i>Ancistrachne uncinulata</i> (sparse to moderately dense).</p>

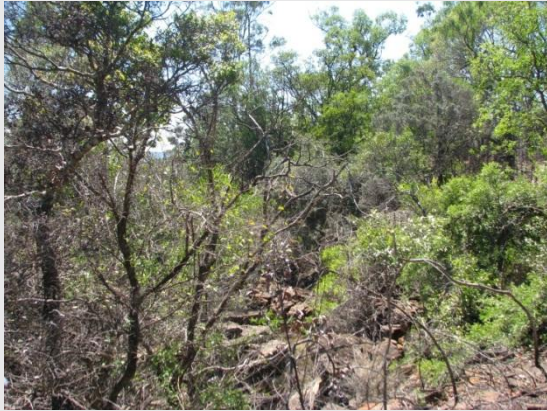
Polygon	Mapped RE	Observed RE	Community Description	Representative Photo
11	11.10.1/11.10.13 a	11.9.4a	<p>This polygon is located in the north-eastern extent of Lot 20 on FTY1805.</p> <p><b>Land zone:</b> Occurs on landforms derived from underlying or outcropping sedimentary rock, including Jurassic quartzose sandstone, sub-labile and labile sandstone, mudstone, consistent with land zones 9 or 10. Landforms are derived from the Evergreen formation and Boxvale Sandstone Member.</p> <p><b>Tree Layers:</b> Field surveys found this area to contain semi evergreen vine thicket with an emergent layer (11–13 m) of <i>Brachychiton</i> spp. and a tree layer dominated by <i>Diospyros humilis</i>. Other associated tree species observed includes <i>Flindersia australis</i>, <i>Atalaya hemiglauca</i> and <i>Brachychiton</i> spp..</p> <p><b>Shrub Layers:</b> The shrub layer was dominated by <i>Geijera parviflora</i>, <i>Ficus rubiginosa</i> and <i>Carissa ovata</i> with associated species consisting of <i>Cupaniopsis anacardioides</i>, <i>Denhamia oleaster</i>, <i>Psyrax odorata</i> and <i>Turraea pubescens</i>.</p> <p><b>Ground Layer:</b> The groundcover consisted primarily of grass species (sparse to moderately dense) including <i>Ancistrachne uncinulata</i>, <i>Themeda avenacea</i> and <i>Aristida caput-medusae</i>.</p>
